# FALL KILL WATERSHED NEIGHBORHOOD SOURCE ASSESSMENT

**A survey of pollution potential  
and restoration opportunities**

Prepared in 2012-2013, by Hudson River Sloop  
Clearwater and the Fall Kill Watershed Committee

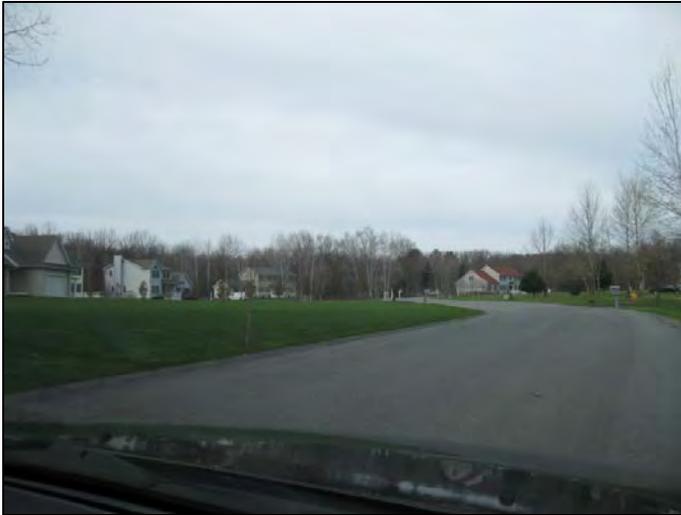
**Tree planting opportunity in Neighborhood 7.**

wind barrier, leading to lower energy costs; reducing urban heat island effect in cities; and absorbing air pollutants. But trees are especially good at reducing stormwater runoff. Trees can intercept rainfall, diminish the impact of rain on barren soil and minimize soil moisture, which can allow more water to infiltrate the ground. Trees can also provide shade from the summer sun for lawn turf, which could reduce the need to irrigate and fertilize lawns. Because trees take a long time to mature, and because their full benefits will not be immediately realized, maintaining open space as much as practicable is also recommended. Increasing impervious

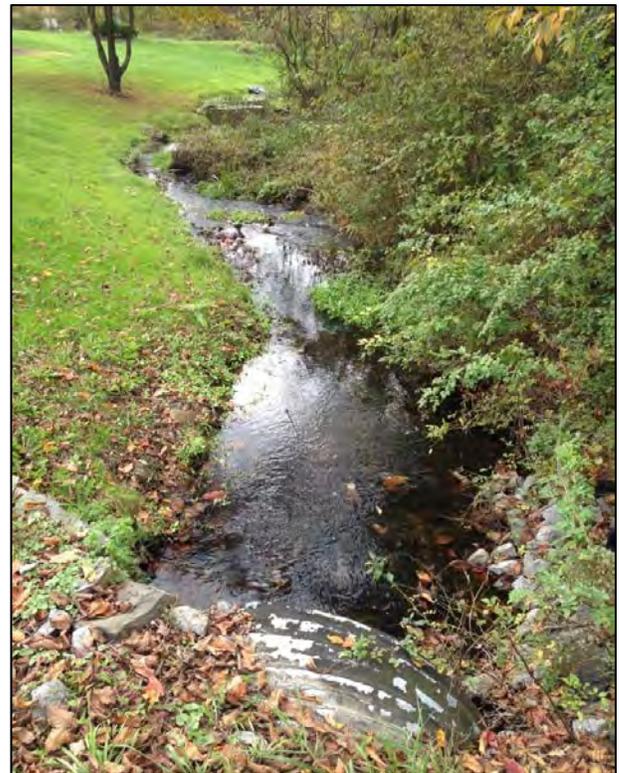
Several neighborhoods in Hyde Park were observed to have riparian areas that were encroached upon, usually by a landowner who has cleared trees and brush along the creek. Healthy riparian buffers naturally slow and filter pollution runoff and help protect against soil erosion and sediment loading. Trees along riparian corridors help to regulate temperatures in the water, which is important for aquatic species. A vegetated buffer will also discourage Canada geese from grazing along the creek side, which will help prevent coliform loading from geese waste.

**Example of a buffer restoration opportunity, NBD 2.**

Wherever possible, native trees and shrubs should be allowed to grow in the riparian area along the creek and tributaries. The Hudson River Estuary Program's "Trees for Tribs" Initiative helps qualifying areas restore a natural riparian buffer and could be one source of assistance for landowners who wish to protect the tributary in their area.

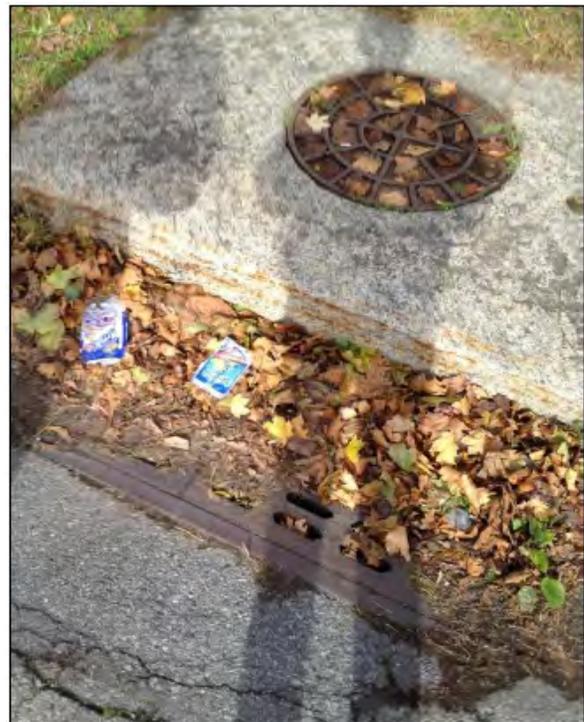
Catch basin with organic debris and litter

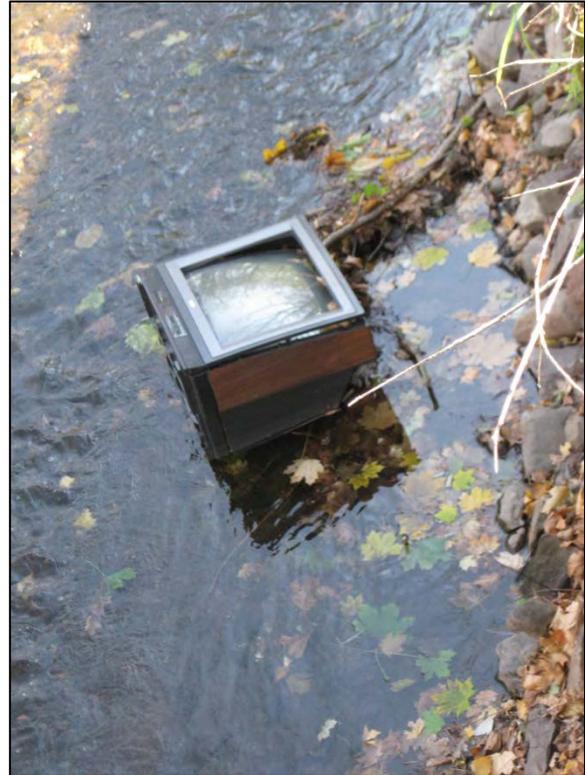
Trash and other debris were observed along many curb sides and at storm drain catch basins. Larger trash items were also observed in some Poughkeepsie neighborhoods that border the creek, such as Neighborhood 29/Garden Street, where two television sets were observed, one in the creek and the other at the top of the wall looking over the creek.

**Television observed during field investigation**

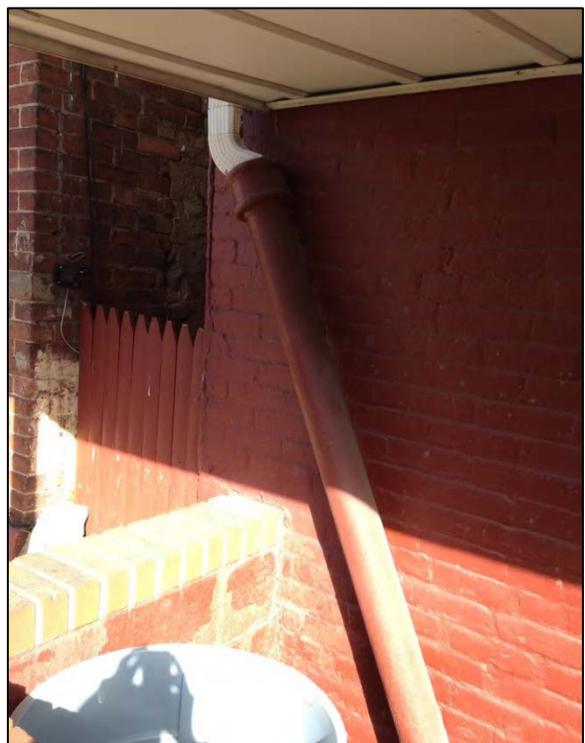
Other neighborhood characteristics that were observed during field investigation were a high percentage of rooftop downspouts that are either directly connected to the sewer or that drain to impervious surfaces. For example, Neighborhood 30/Verrazano Blvd. has an estimated 90 percent of rooftop downspouts draining to impervious surfaces such as driveways, and Neighborhood 25, which spans from Taylor Avenue to Albany Street, has an estimated 60 percent of downspouts directly connected to the sewer.

**A directly connected downspout in NBD 25**

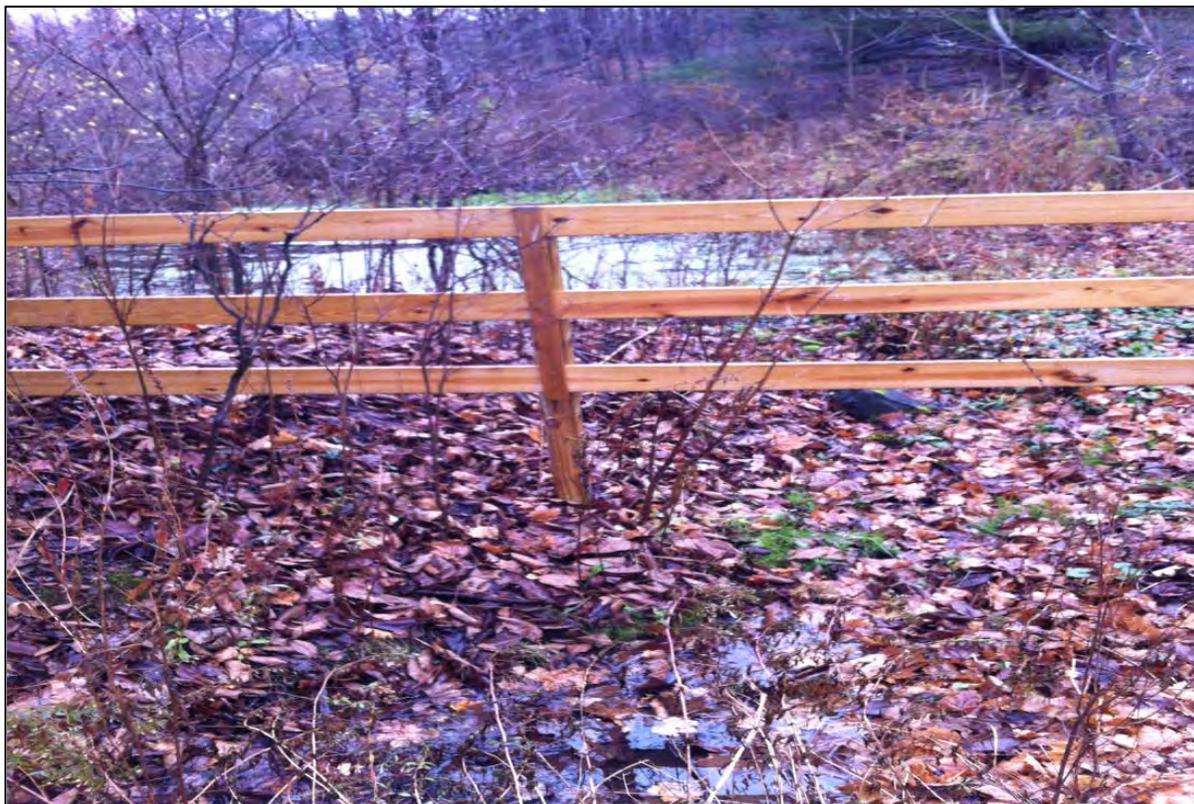
Also of note is a small pond between two houses on the side of the road. This pond was relatively well kept, not overgrown, but did have a significant amount of algae. This provides evidence of nutrient enrichment, possibly from fertilizer use.

**Small pond filled with some algal growth**

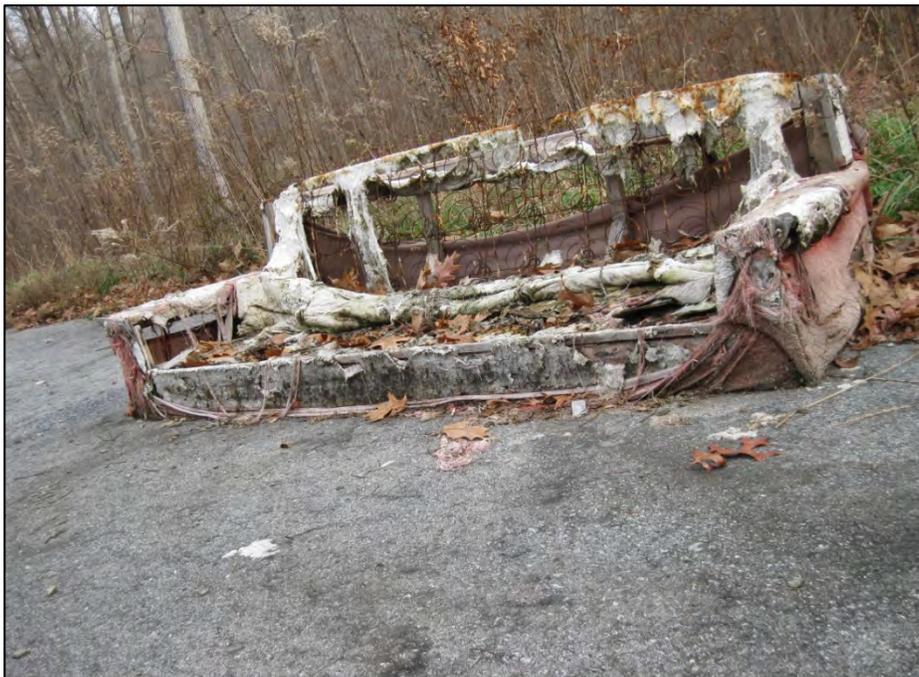
**Burned couch at the cul-de-sac of the unnamed, unfinished subdivision**

Lastly, the area at the southeast portion of the map contains a future subdivision, with road and curb constructed, gas utilities and stormwater infrastructure installed, and subdivided lots ready for construction. While the unnamed road is blocked off by large boulders, it is evident that people are accessing the site. Large debris such as burned couches (see photo) and other garbage are present everywhere at the cul-de-sac. Stormwater runoff could carry pollutants from this debris downhill to the stream. Debris should be cleared, and the no-trespassing should be enforced.

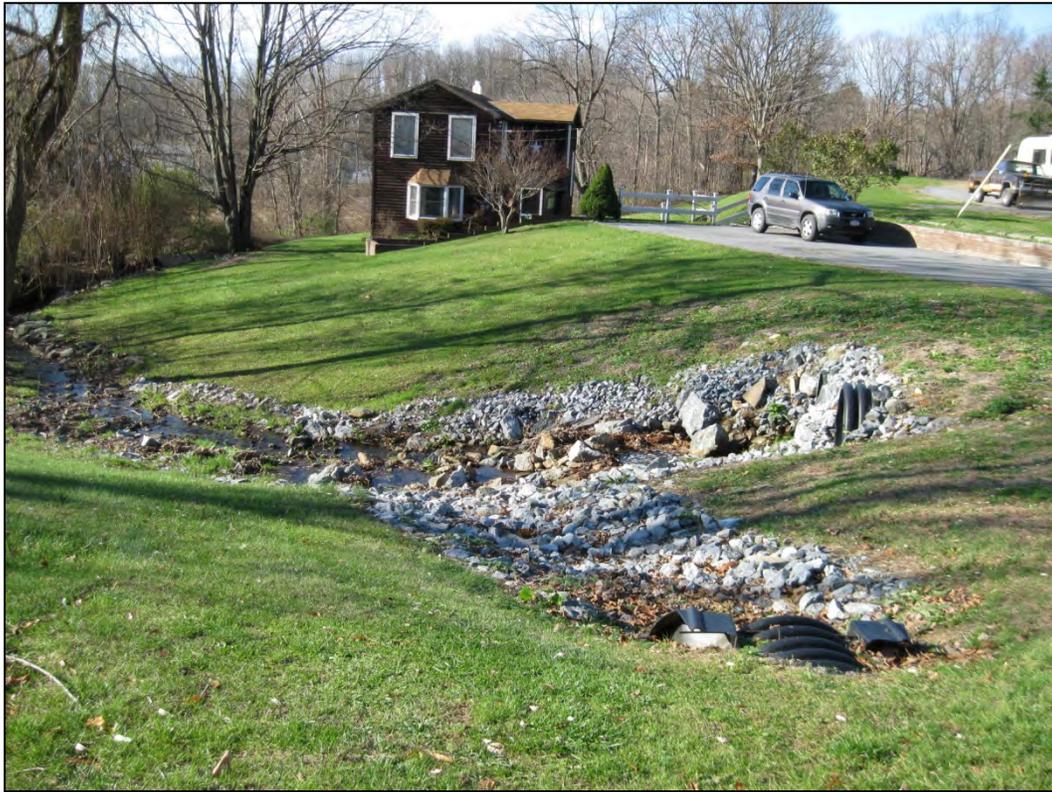
This combination of factors causes problems with erosion, sedimentation, and flooding throughout the neighborhood, and poses challenges to residents, particularly along Belvedere Rd., and Edgewater Dr., as seen in the pictures below.

**This residence on Belvedere Rd appears to experience the worst flooding and erosion, where the tributary meanders north.**

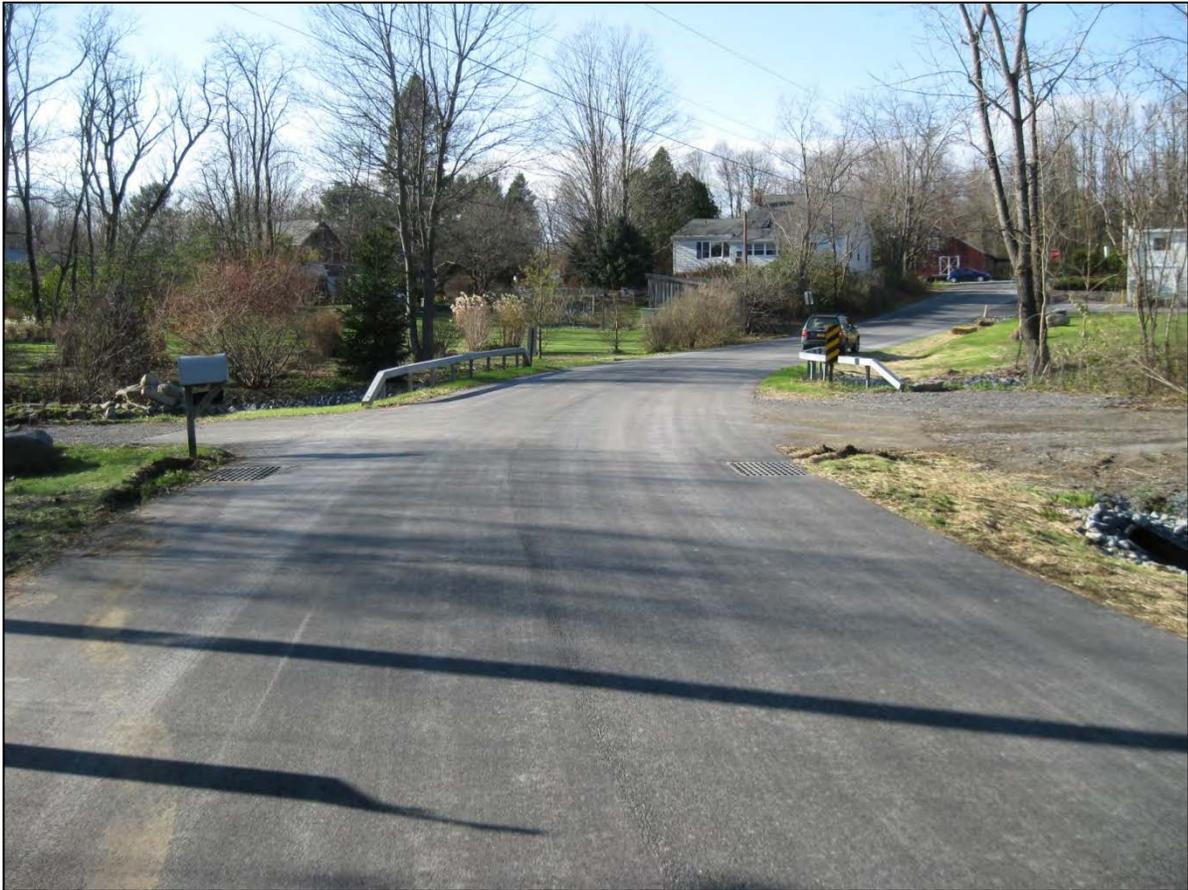
**Looking west on Edgewater towards Salt Pt., notice relatively new trench culverts and geotextile.**

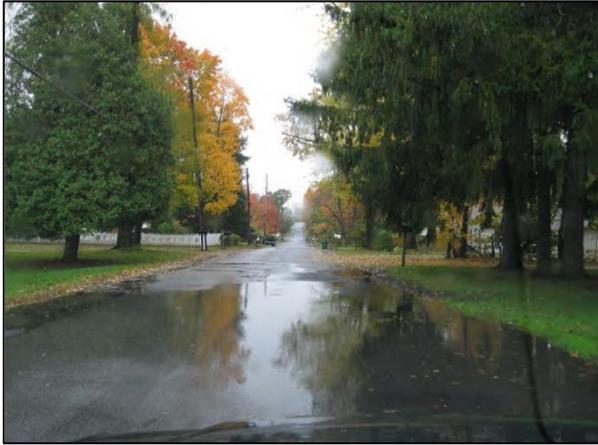
The assessment for Neighborhood 18 was conducted on a day with moderately heavy rainfall, and standing water was observed in several locations, notably on the western end of Bircher Avenue around 13 Bircher Avenue (see photo). Stormwater was also observed running south to north along Pells Court toward Bircher Avenue. An asphalt berm was constructed along a good portion of Pells Court to direct the storm water down the street rather than into yards and homes (see photo).

**Standing water on Bircher Ave.**

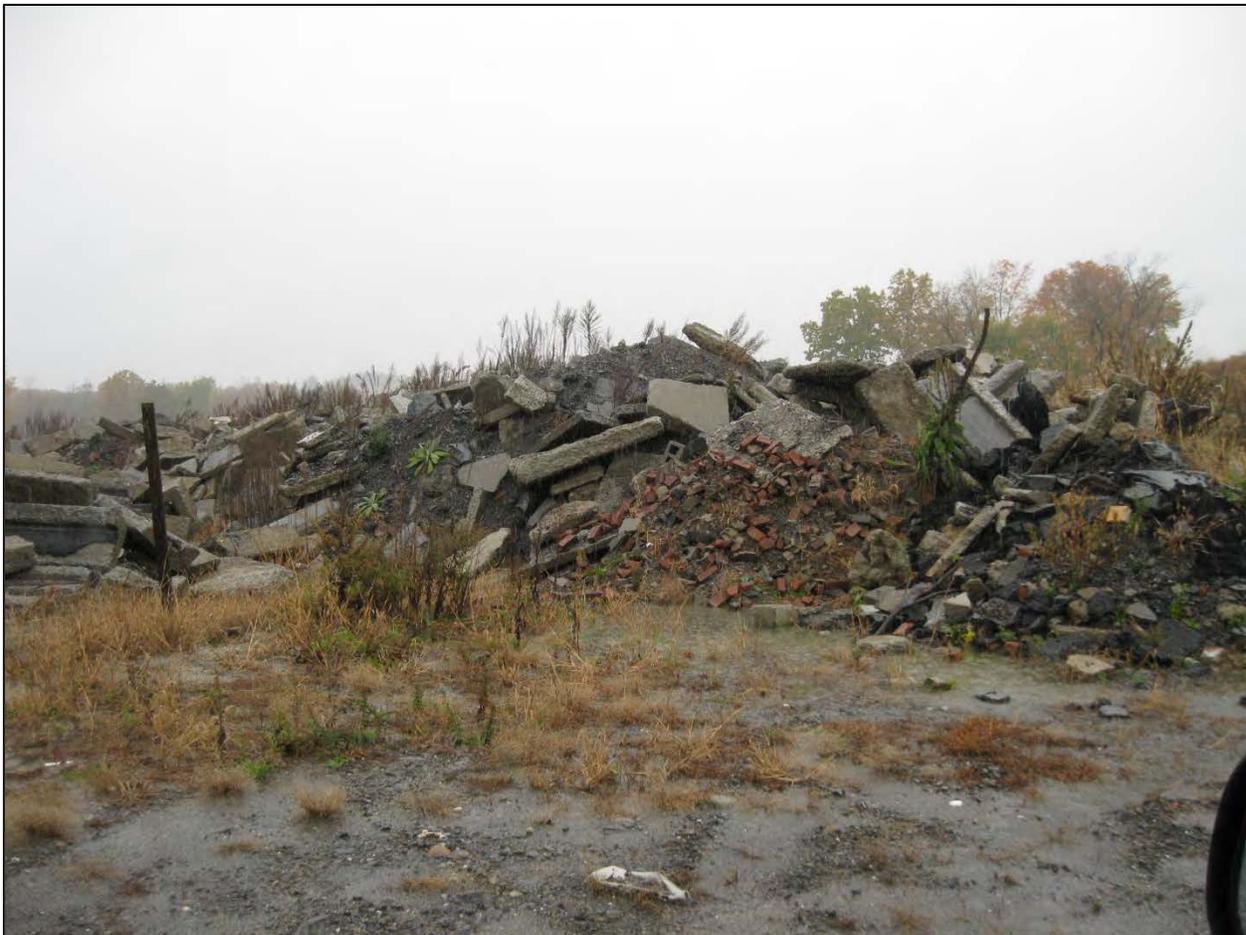
**Construction debris, southern portion of development.**

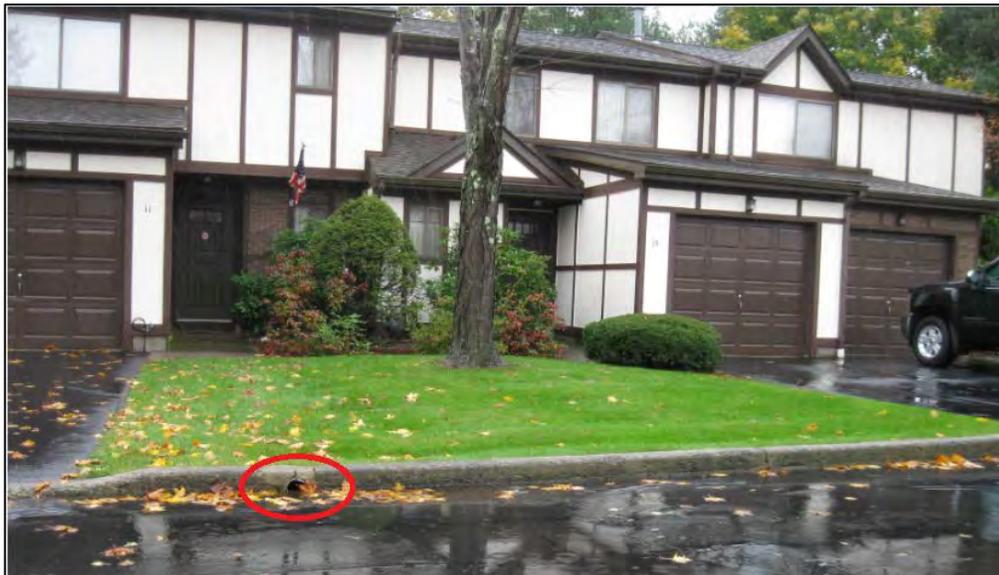
**Example of roof rainwater directed to impervious surface, site B**

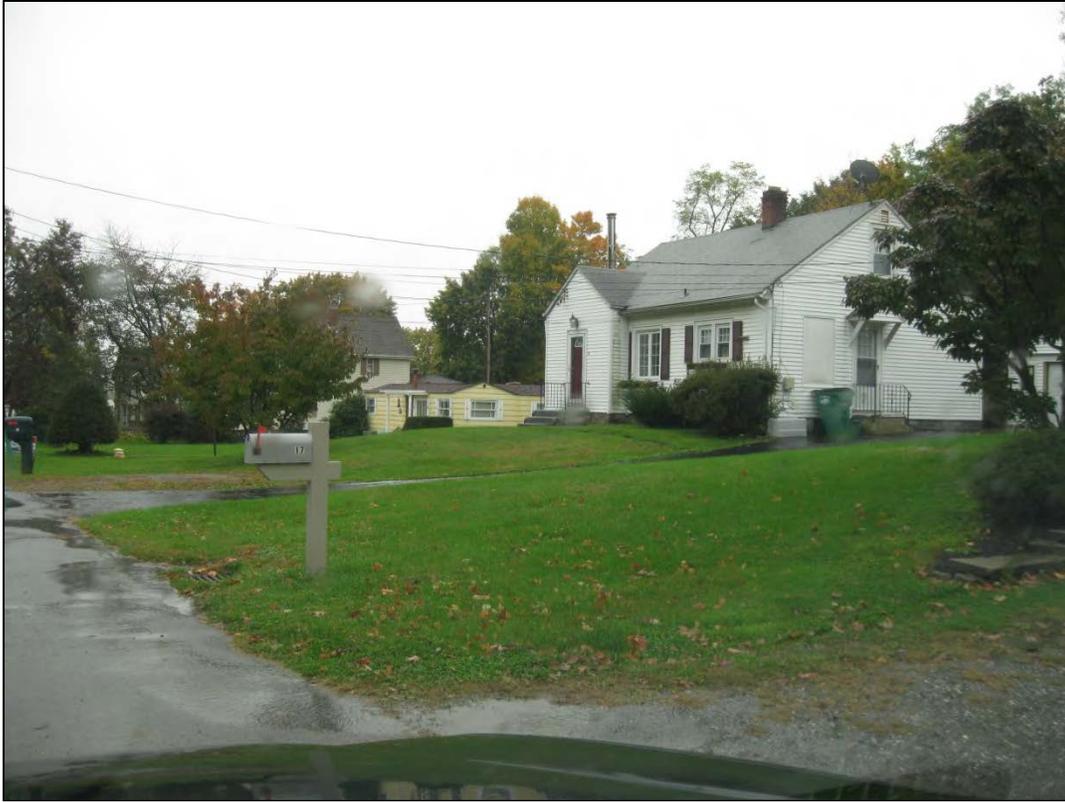
**Front yard tree planting opportunity at 17 School Street**

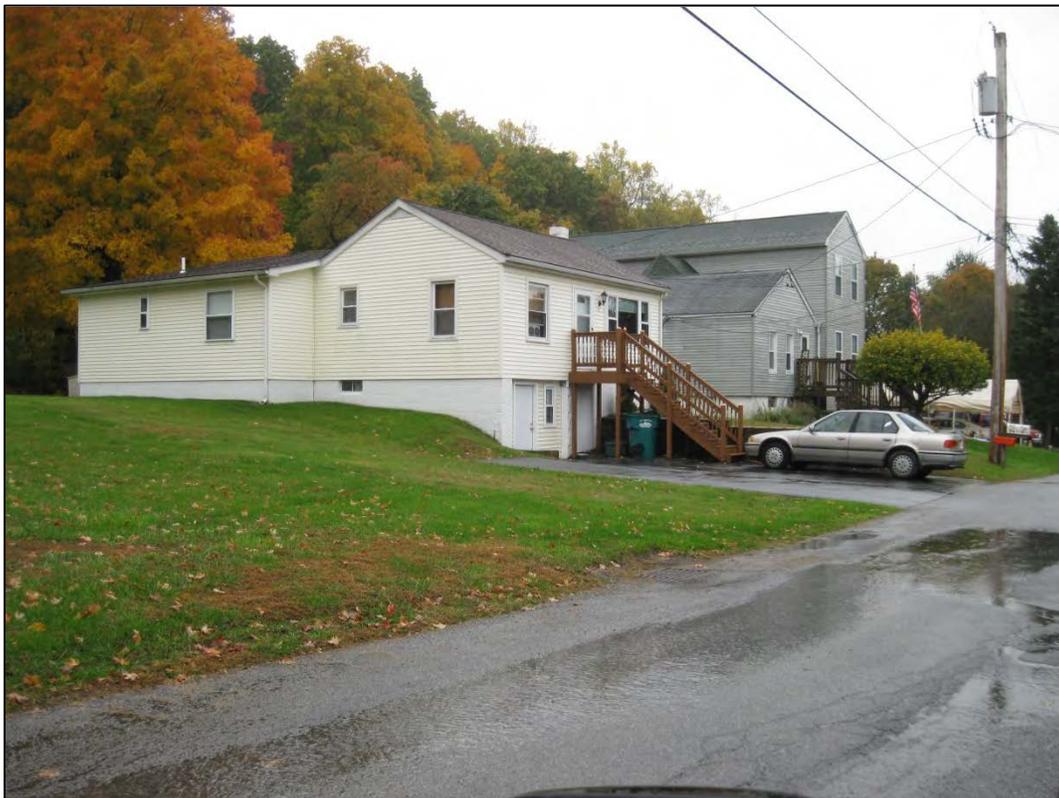
**Tree planting opportunity**

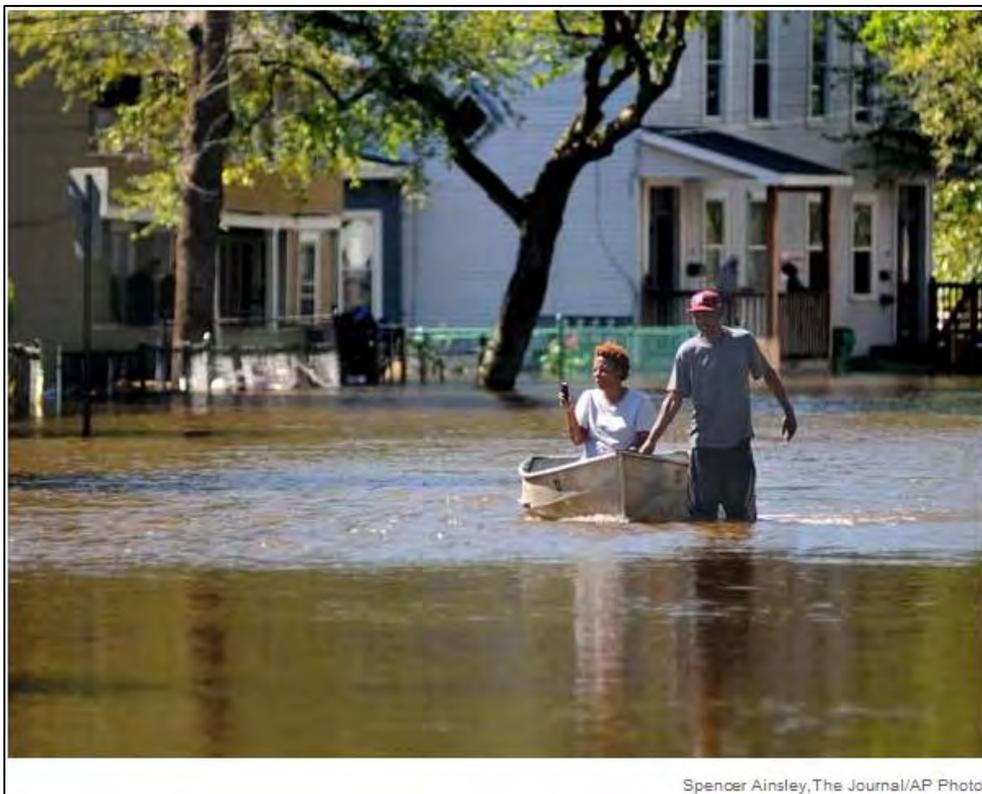
**Residents on flooded Winnikee Avenue after Hurricane Irene in 2011.**

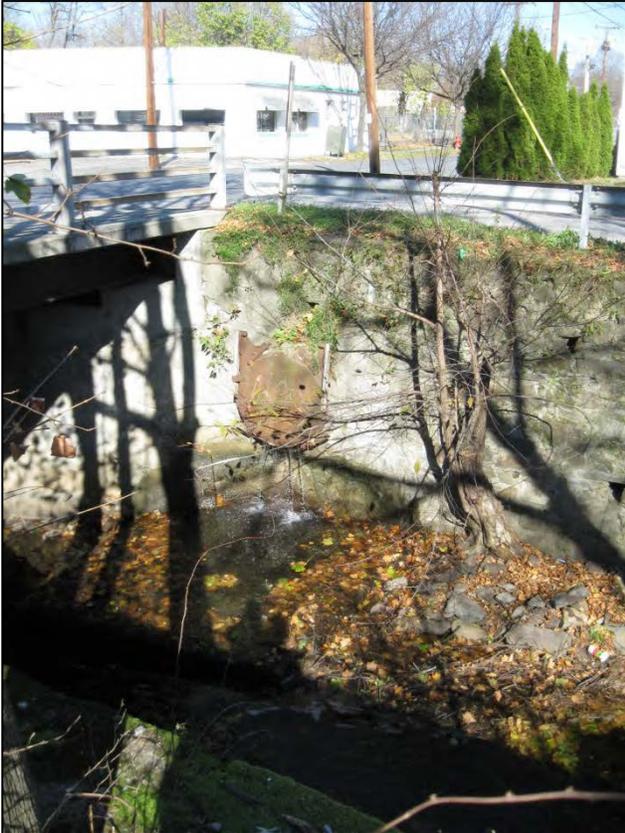
**Garden St outfall in dry weather.**

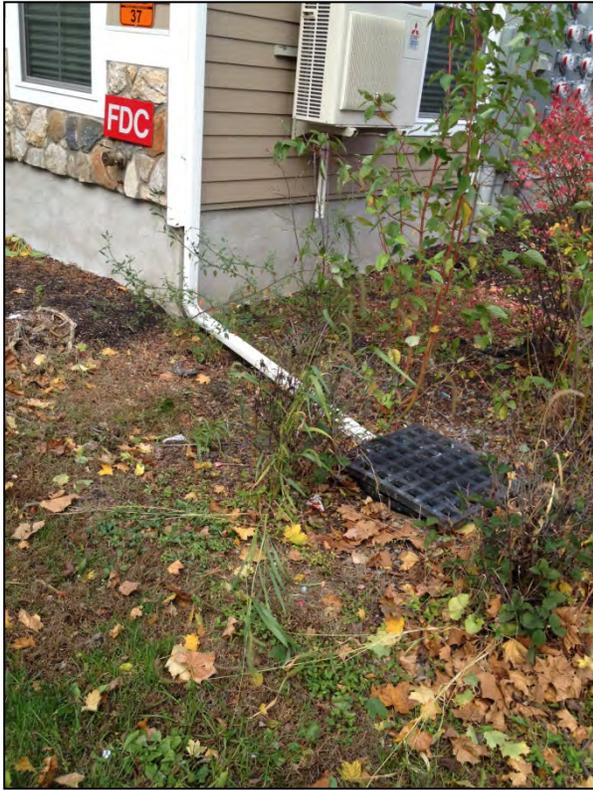
**Downspout from Baxter apartment building connected to drain.**
