### **3.4 RIPARIAN VEGETATION ECOLOGY AND MANAGEMENT**

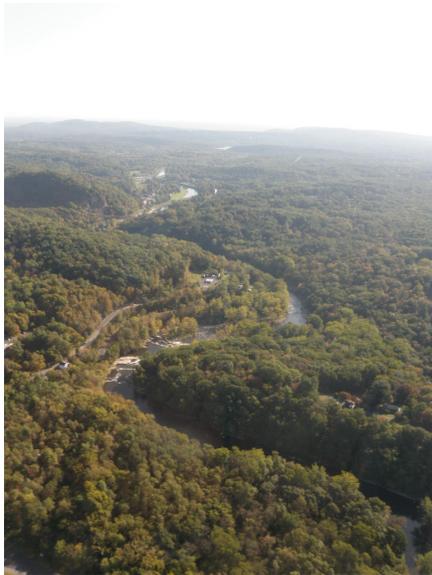
**Photo 3.4.5** Healthy riparian buffer of lower Rondout Creek as it flows adjacent to Route 213 through the Town of Rosendale.

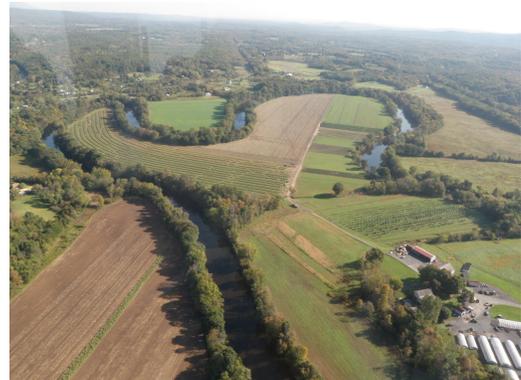
**Photo 3.4.6** Lower Rondout Creek meandering through the farms of Accord.

Secondly, as the lower Rondout begins its meandering journey through the agricultural valley floor, it becomes more entrenched and with little vegetative buffer between the Rondout and its adjacent agriculture fields.

Vegetation is typically limited to the steep stream banks with little (ie. a single line of trees) if no buffer on the floodplain. Some of these banks are more than 20 ft. in vertical height and vegetation serves as the only real stabilizing protection for the Rondout. One of the reasons the lower Rondout has become more entrenched is the berm building that has taken place with increased sediment loads from agriculture and development runoff.

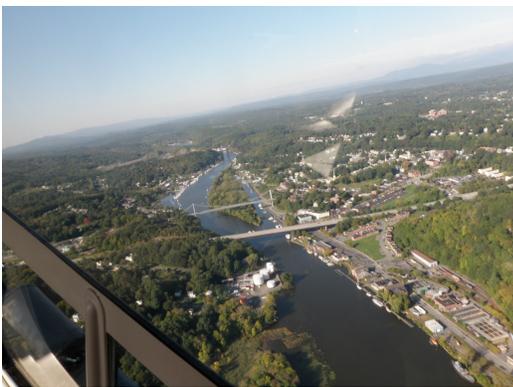
**Photo 3.4.9** Lower Rondout Creek entering Kingston flanked by roads and development on both sides of the stream.

The alignment Route 209 and Route 213 closely follows the stream alignment of the lower Rondout Creek. Use and maintenance of these roads has a significant impact on the riparian vegetation. The narrow buffer of land between the creek and the road receives runoff containing salt, gravel, and chemicals from the road that stunt vegetation growth and increase mortality. Road maintenance activities also regularly disturb the soil along the shoulder and on the road cut banks. This disturbance fosters the establishment of undesirable, invasive plants, which establish more quickly than native vegetation in these areas. The linear gap in the canopy created by the roadway separates the riparian vegetation from the upland plant communities. This opening also allows light into the vegetative understory, which may preclude the establishment of native, shade-loving plants such as black cherry and hemlock.
