### **3.4 Riparian Vegetation Ecology and Management**

## Riparian Vegetation in the lower Non-Tidal Rondout Watershed

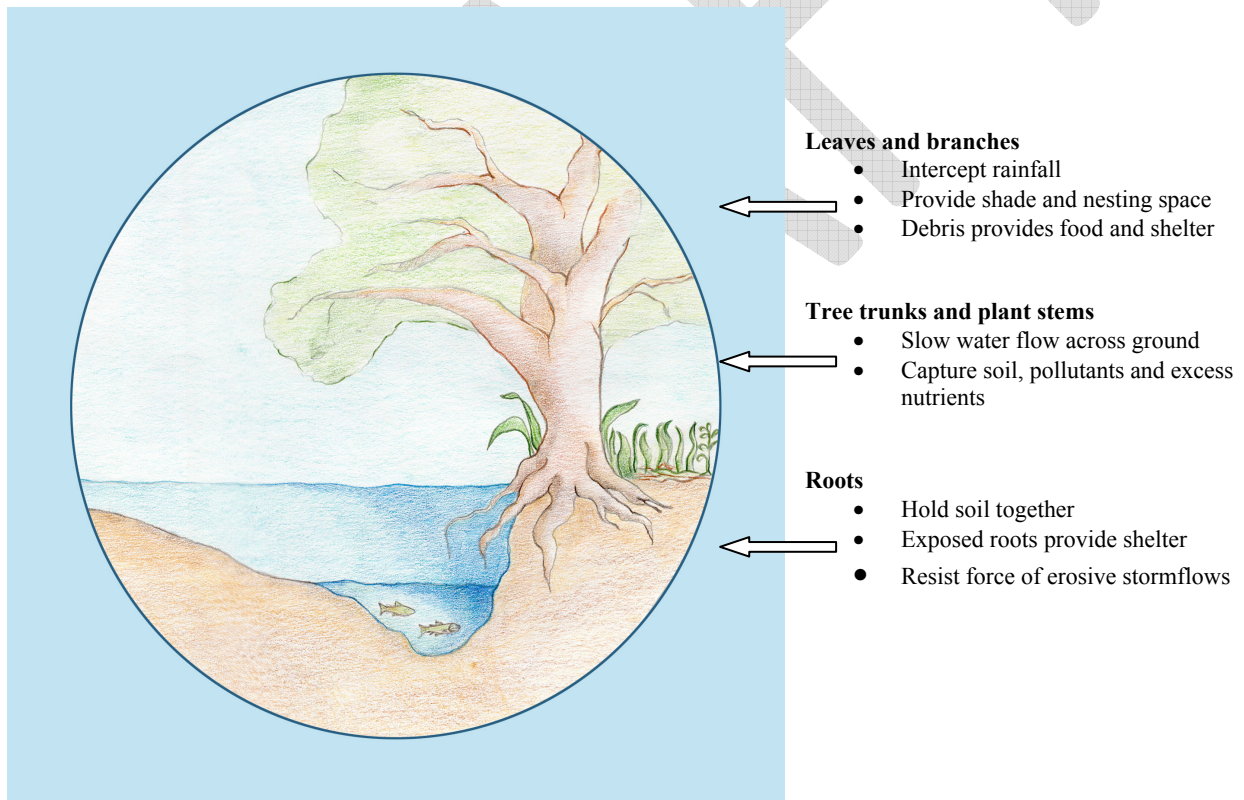
**Figure 3.4.1** Illustrates ecological functions of various plant parts. (Pattv Hanson. LaDue Design)

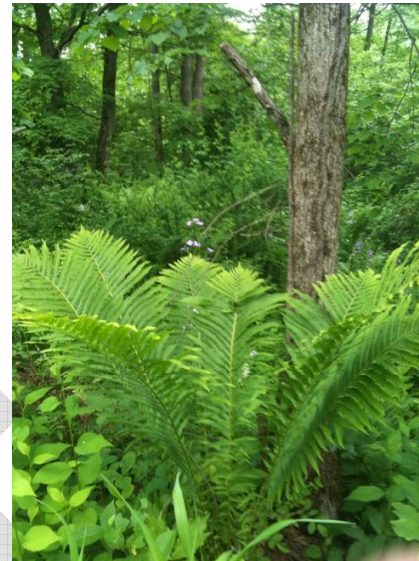
**Photo 3.4.1.** Riparian understory along Rondout Creek.

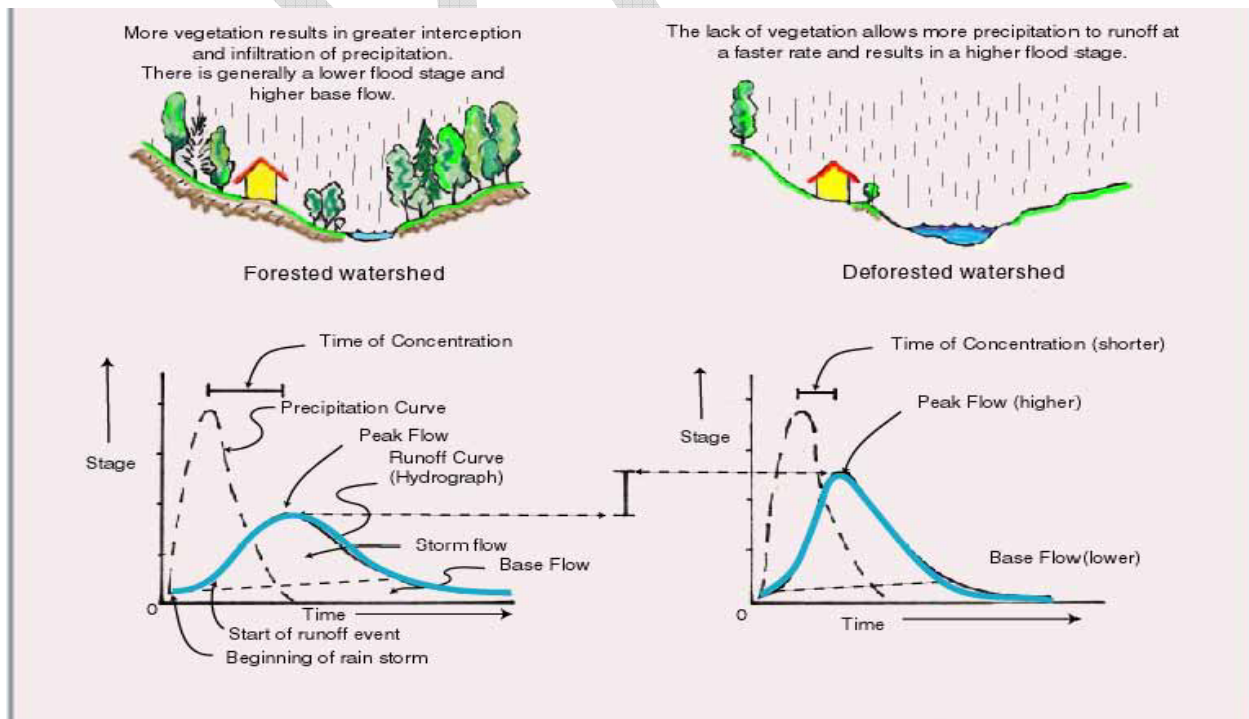
**Figure 3.4.2** Comparison of Runoff on a Forested Watershed Versus a Deforested Watershed. Illustration by P. Eskeli 2002, from Watershed Hydrology, P.E. Black, 1991, Prentice Hall, page 202, 214.

Vegetation intercepts rainfall and slows runoff. This delay increases the amount of precipitation that infiltrates the soil, recharges groundwater supplies and reduces overland runoff. This reduction and delay in runoff decreases the occurrence of destructive flash floods, lowers the height of flood waters, and extends the duration of the runoff event. These benefits are evident in forested watersheds such as the lower Rondout when compared to watersheds of similar size which have high levels of urban development (Fig.2). The reduction in flood stage and duration also results in fewer disturbances to stream banks and floodplains.

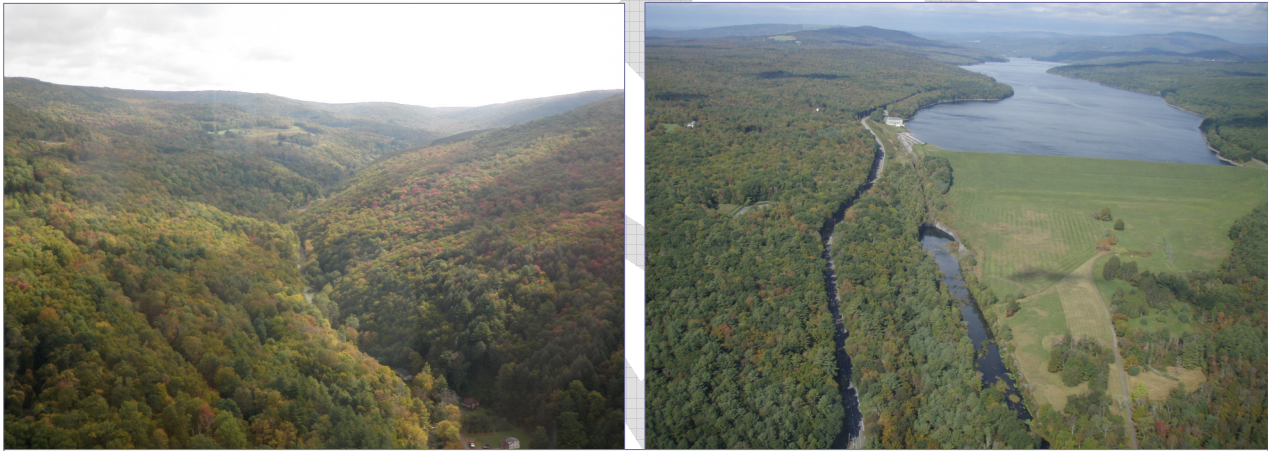
**Photos 3.4.2 & 3.4.3** Primarily forested upper Rondout watershed and lower Rondout Creek as it flows out of the NYC DEP Reservoir.

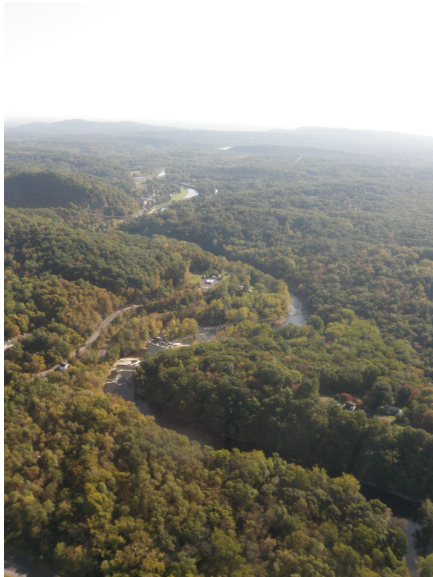
**Photo 3.4.4** Healthy riparian buffer of lower Rondout Creek as it flows adjacent to Route 213 through the Town of Rosendale.

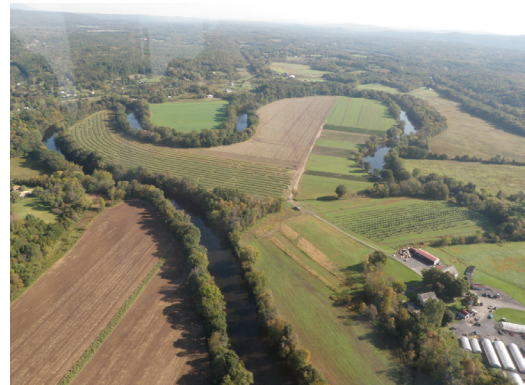
**Photo 3.4.5** Lower Rondout Creek meandering through the farms of Accord.

Secondly, as the lower Rondout begins its meandering journey through the agricultural valley floor, it becomes more entrenched and with little vegetative buffer between the Rondout and its adjacent agriculture fields.

Vegetation is typically limited to the steep stream banks with little (ie. a single line of trees) if no buffer on the floodplain. Some of these banks are more than 20 ft. in vertical height and vegetation serves as the only real stabilizing protection for the Rondout. One of the reasons the lower Rondout has become more entrenched is the berm building that has taken place with increased sediment loads from agriculture and development runoff.

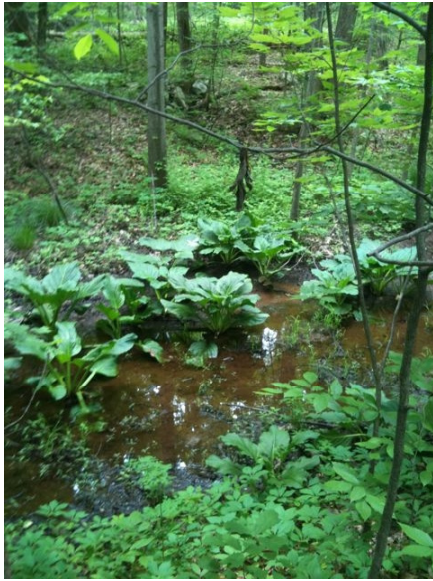
**Photo 3.4.6** A wetland indicator, skunk cabbage, thrives in the riparian areas along the lower Rondout Creek amongst a variety of other understory vegetation.

Typically, riparian forest communities consist of species that thrive in wet locations and have the ability to resist or recover from flood disturbances. Extensive riparian communities typically exist in floodplain or wetland areas where a gentle slope exists. Many of the species present in these plant communities are exclusive to riparian areas. In areas where a steep valley slope exists, the riparian community may occupy only a narrow corridor along the stream and then quickly transition to an upland forest community. Soils, ground water and solar aspect may create conditions that allow the riparian forest species to occupy steeper slopes along the stream, as in the case where hemlock inhabits the steep, northfacing slopes along the watercourse.

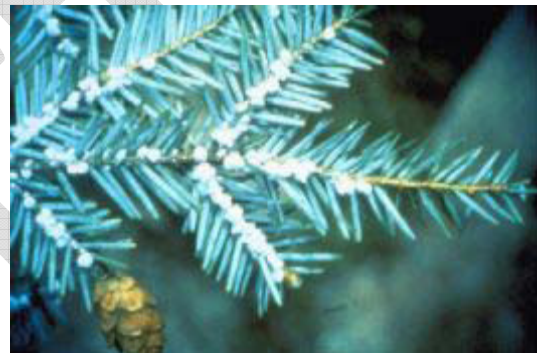
**Photo 3.4.6** Hemlock woolly adelgid on the underside of a Hemlock branch

Pests and diseases that attack vegetation can also affect changes in the ecology of the riparian area and could be considered a disturbance. The hemlock woolly adelgid (*Adelges tsugae*) is an insect, which feeds on the sap of hemlocks (*Tsuga spp.*) at the base of the needles causing them to desiccate and the tree to take on a grayish color (Fig. 4). Stress caused by this feeding can kill the tree in as little as 4 years or take up to 10 years where conditions enable the tree to tolerate the attack (McClure, 2001). This native insect of Japan was first found in the U.S. in Virginia in 1951 and has spread northward into the Hudson Valley and Catskills (Adams, 2002).

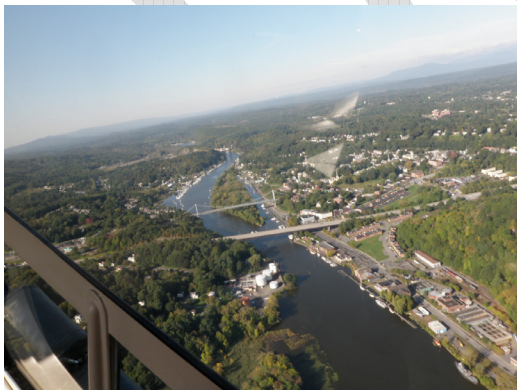
**Photo 3.4.7** Lower Rondout Creek entering Kingston flanked by roads and development on both sides of the stream.

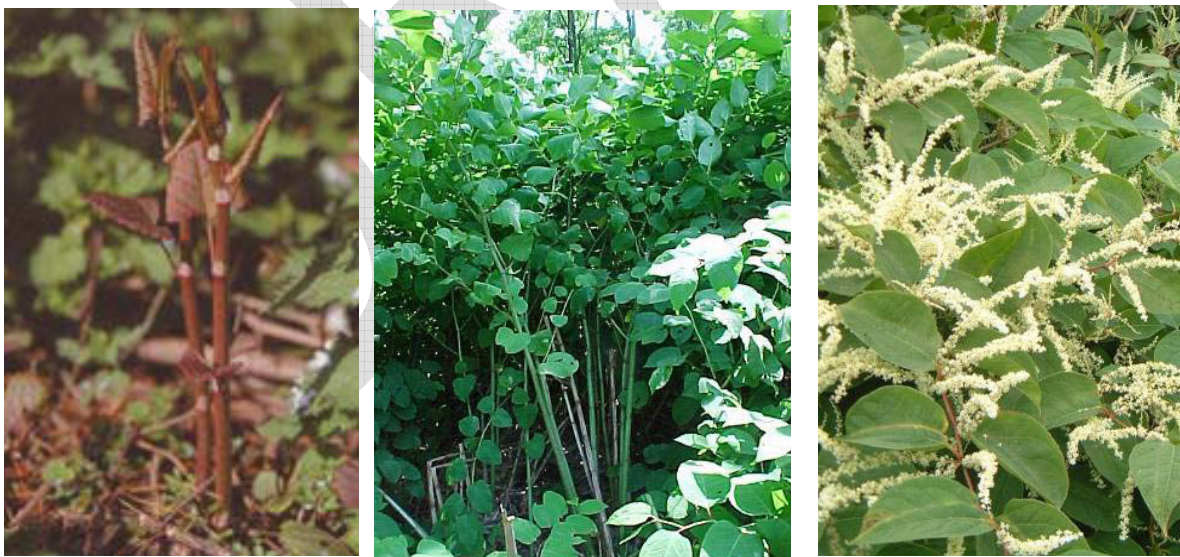
Figure 3.4.3 (a), (b), and (c) Stages of Japanese knotweed’s growth throughout the growing season.

The spread of Japanese Knotweed (*Fallopia japonica*), an exotic, invasive plant gaining a foothold in many streams in the Hudson Valley, is an example of a plant causing such a disruption. As its common name implies, Japanese knotweed’s origins are in Asia. It shades out existing vegetation and forms dense stands along the bank (Fig. 5 a-c). Although the impact of a Japanese knotweed invasion on the ecology of the riparian area is not fully understood, the traits of Japanese knotweed pose several concerns. Some of these concerns include:

- Knotweed appears to be less effective at stabilizing streambanks than deeper-rooted shrubs and trees, possibly resulting in more rapid bank erosion.
- The shade of its broad leaves and the cover by its dead litter limit the growth of native plants that provide food and shelter for associated native animals.
- Knotweed branches do not lean out over stream channels, providing little cooling from shade.
- Dead knotweed leaves (*detritus*) may alter food webs and impact the food supply for terrestrial and aquatic life.
- Large stands of knotweed impede access to waterways for fishing and streamside hiking.
- The presence of knotweed could reduce property value.
- Knotweed may alter the chemical make-up of the soil, altering soil microfauna and soil properties.
