This Week on the Sloop

December 10-17, 2015

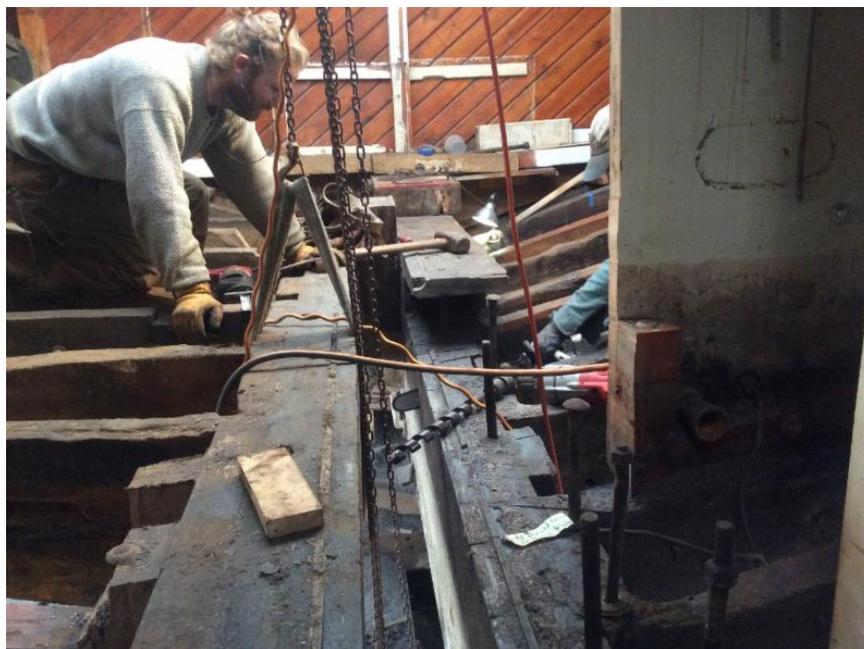
In this photo, the mallet is sitting on top of the forward keelson scarf (a sloped joint used to make up long timbers from shorter sections), while crew continue removing the starboard bedlog. The port bedlogs are suspended by a chain fall, ready to be lowered to the deck of the barge.

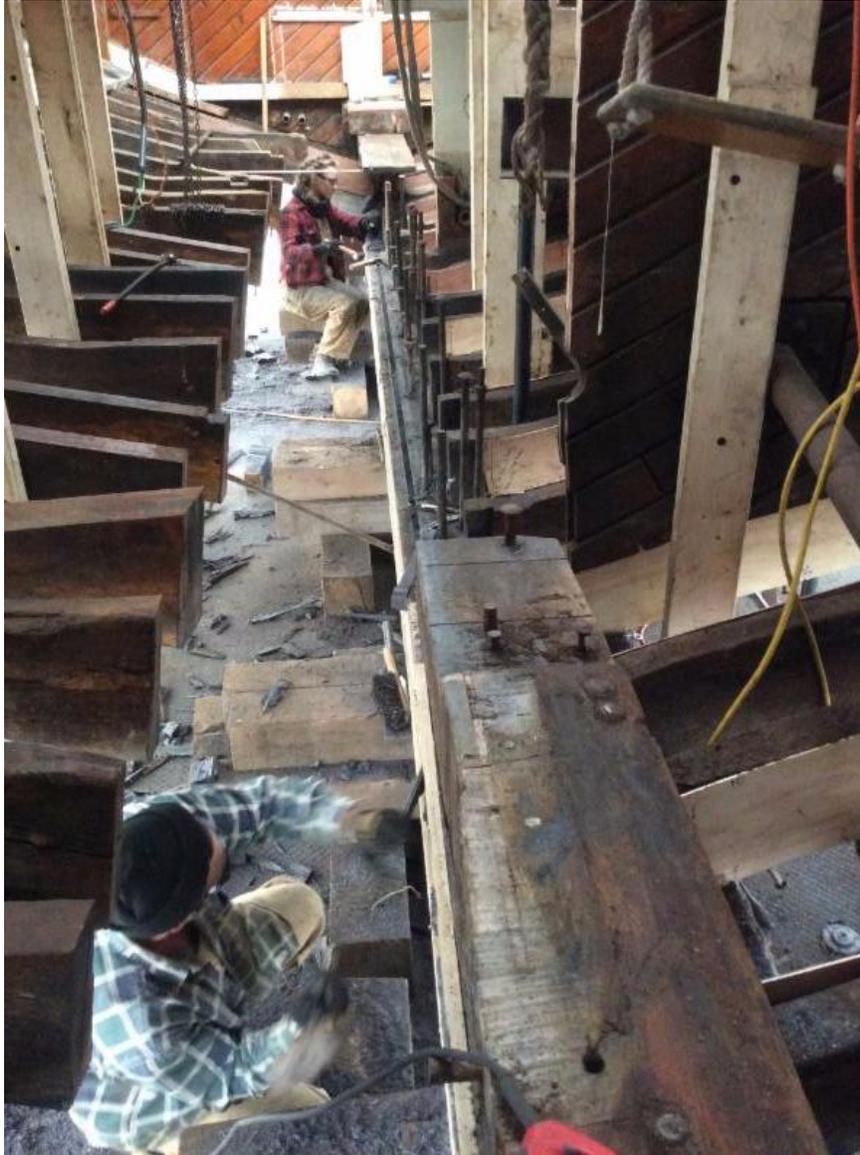
Bodhi and Lydia are sitting where the port bedlogs used to be. They're working on removing the last of the starboard bedlog, which is located beneath the keelson.

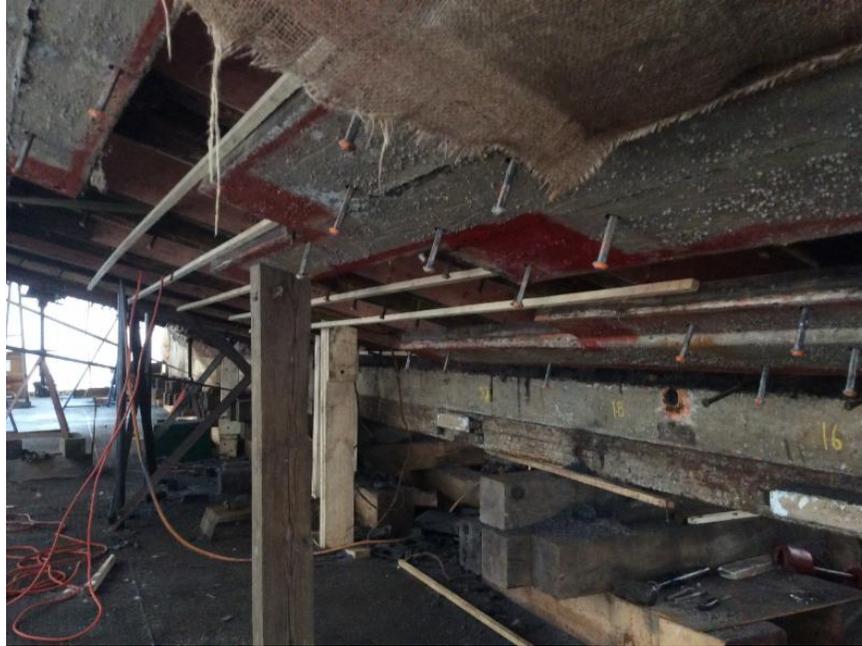
Thin strips of wood called battens are used to make sure the patterns for the new frames are all "fair," meaning that the planks will have a smooth surface to sit against, without recesses and protrusions. The burlap shown in the photo covers the planks replaced in the bow in 2010 and in the stern in 2013. We will wet the burlap with salt water once a week, to keep the planks moist, so they don't shrink too much.

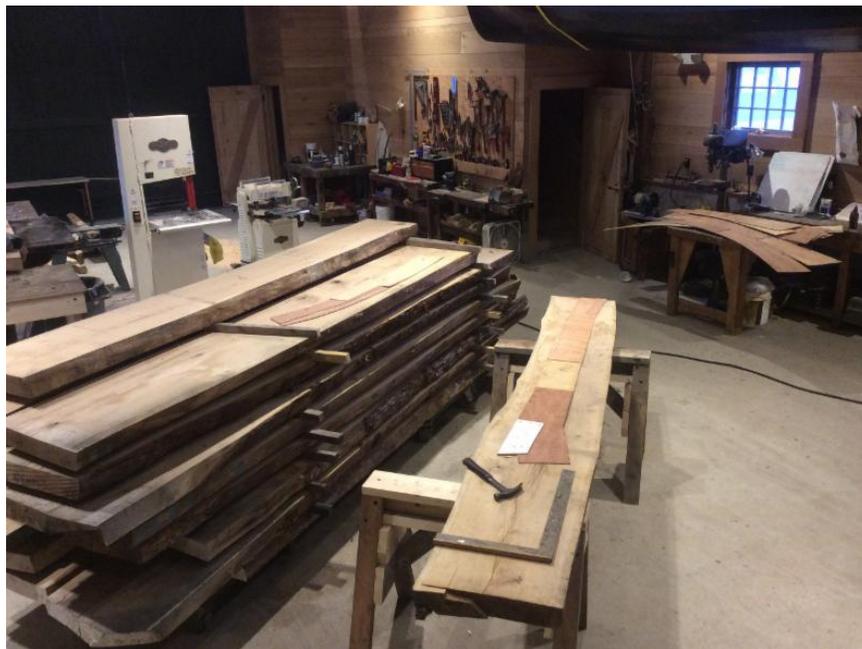
After the patterns are all faired, we lay them out on slabs of lumber, and cut them out on the ship saw.

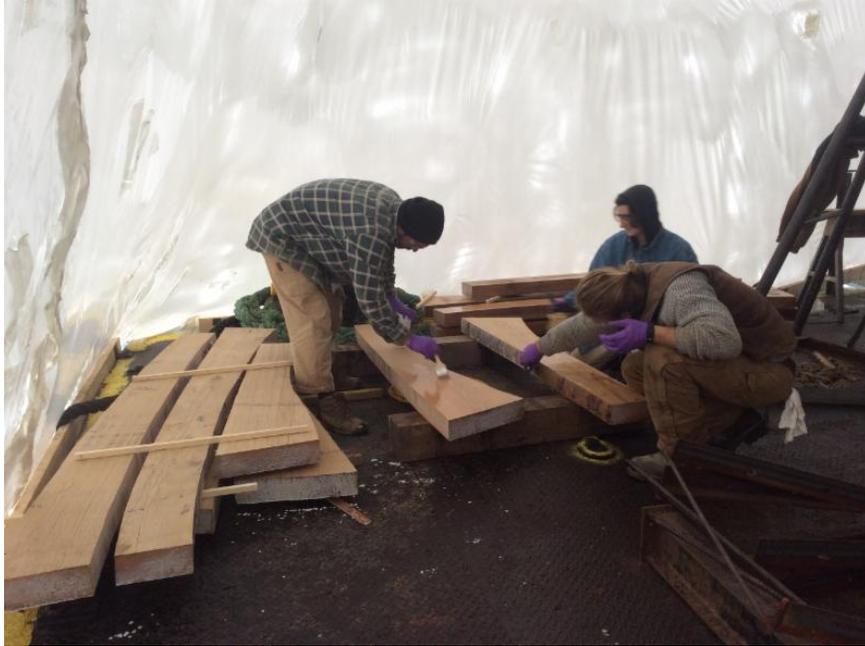
These frames were cut using the shipsaw and we applied borate to protect the frames against insect intruders.

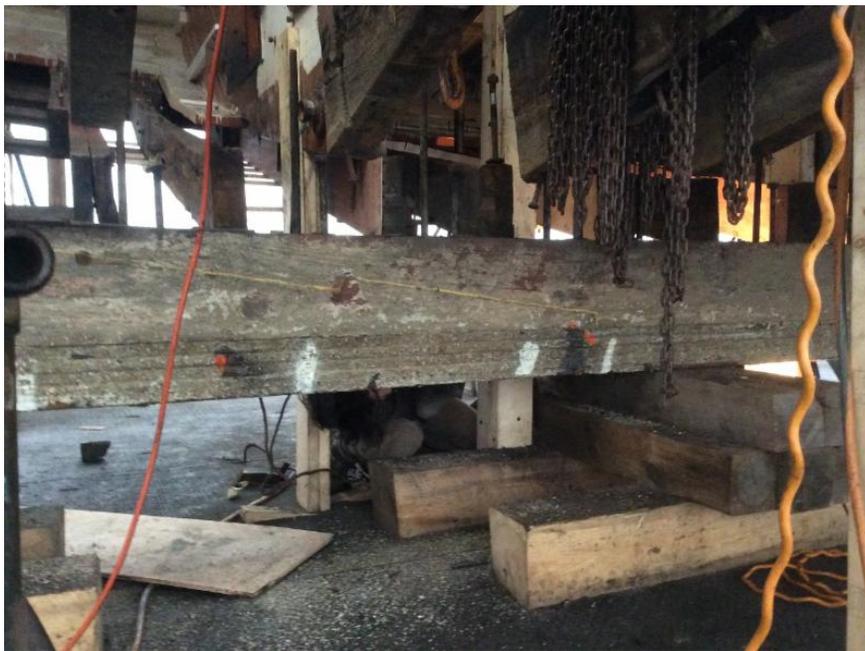
This week we also located all of the fasteners that attach the keel shoe (a five inch thick layer of steel) to the bottom of the keel. We'll remove that shoe in order to access the fasteners that will connect the keelson and starboard bedlog to the keel.

In the upcoming weeks, we will cut scarfs into the replacement section of keelson, and remove the steel keel shoe, in order to remove all of the bolts that connect the centerboard trunk, keelson, starboard bedlog, and keel together.
