## **SECTION 4 - WATER QUALITY**

### **Section 4.1 WATER QUALITY ASSESSMENTS:**

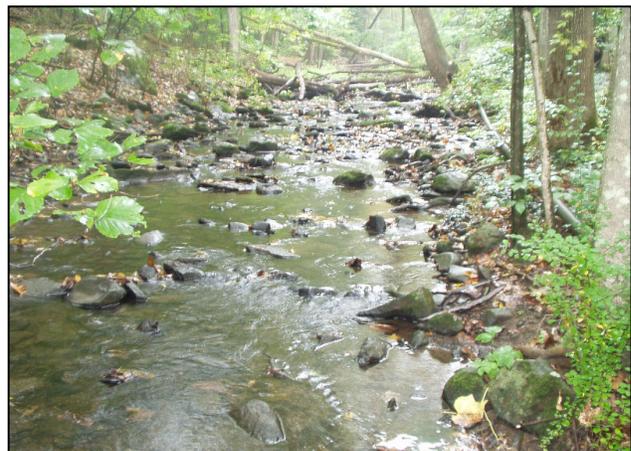
**Photo 4.1.1 Looking upstream from sampling site Tan House Brook, Snyder Estate, Rosendale.**

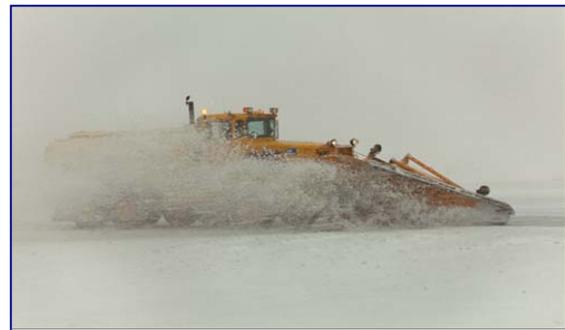
Photo 4.1.3 Non-Point Sources: Salt loading

Non-point nutrients can come from a variety of sources including agricultural areas, golf courses, and urban areas. In addition these nutrients can come from “well-treated sewage effluent” which refers to effluent from septic systems or WWTPs in which the organics have been broken down but nutrient concentrations remain. There is widespread agricultural activity in the Rondout Valley, but it may be more likely that the Rondout’s drop to “slightly impacted” below the confluence with the Sandburg Creek is from urban runoff entering Sandburg Creek from the Village of Ellenville and contributions from various WWTP discharges.

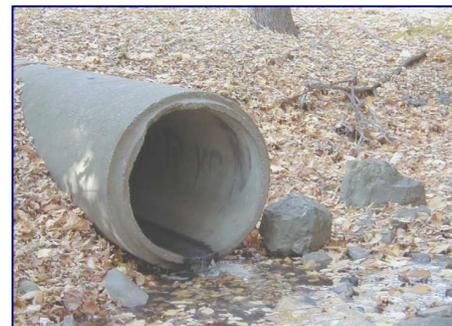
Fig. 4.1.4 Point Sources = End of Pipe

Point Source Pollution: There are several SPDES discharges in the Rondout Creek Watershed in the Town of Wawarsing, none in the towns of Rochester and Marbletown, and one in the Town of Rosendale. The 2007 assessments looked at sites upstream and downstream of four wastewater treatment plants (WWTPs): Ellenville, Napanoch, Kerhonkson, and Rosendale.

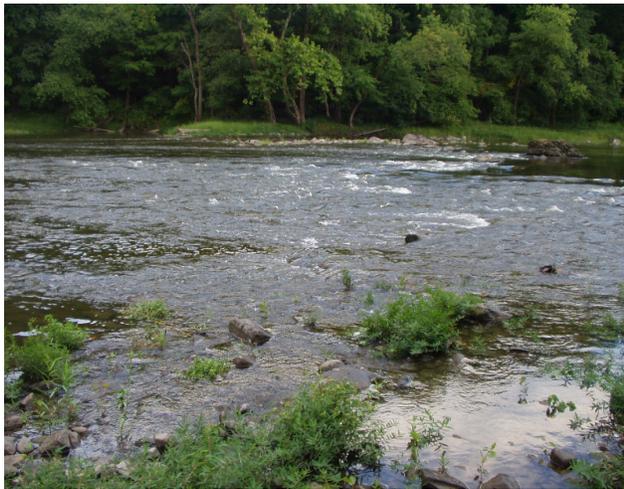
Fig. 4.1.5 Rondout Creek immediately downstream of confluence with Walkkill below Sturgeon Pool

**Site RN15, Creeklocks Road  
September 15, 2007, 5 p.m.**

The most impacted site in the whole watershed (found to be “moderately impacted” in the 2007 HBRW assessment) is located downstream from the confluence with the Wallkill River and is greatly affected by large changes in flow from the Central Hudson hydroelectric dam at Sturgeon Pool. Photos in Fig. 4.1.6 were taken at that site at 5 p.m. one day (shortly after a release) and 9 a.m. the following day after the high waters had subsided. The difference in flow in that 16-hour period is significant.

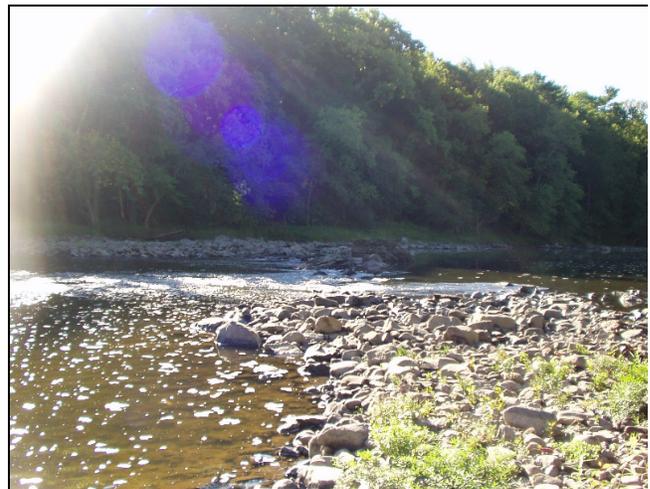
**Site RN15, Creeklocks Road  
September 16, 2007, 9 a.m.**

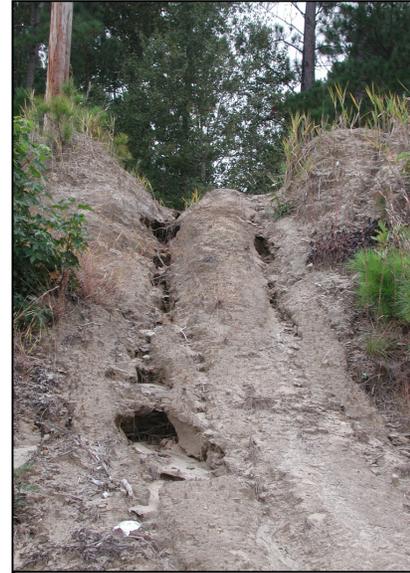
Fig. 4.1.7: Severe erosion.
