# Hudson River PCBs CAG Meeting

Dr. Peter deFur Environmental Stewardship Concepts, LLC March 22, 2012

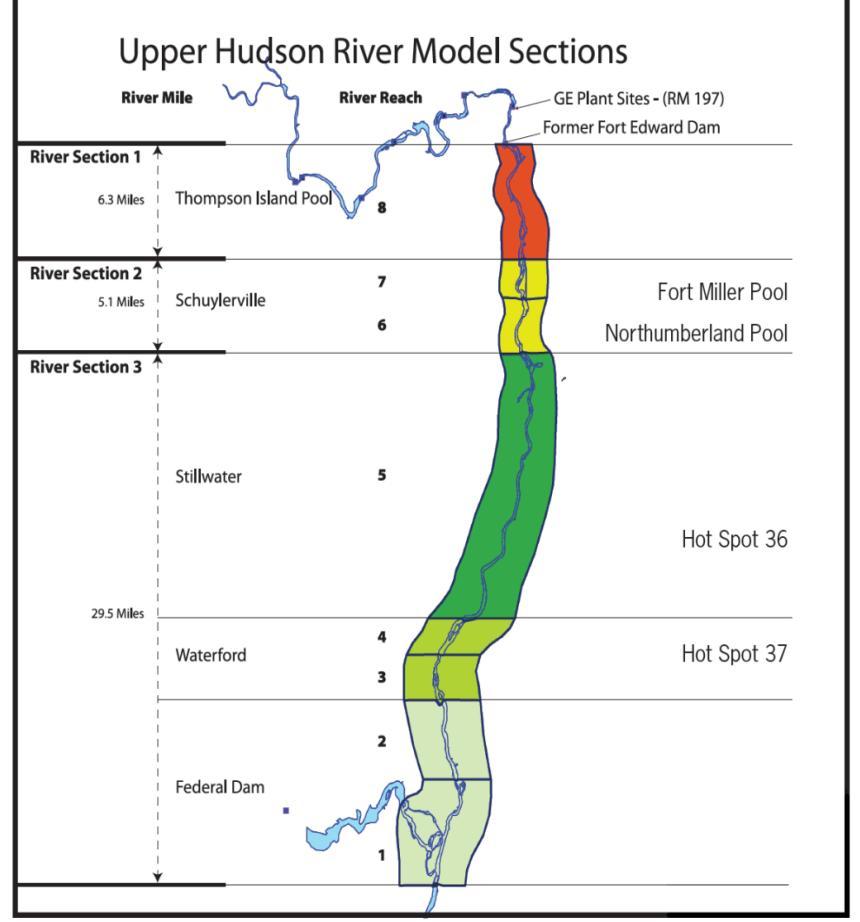
• River Section 1

- 3 grams/meter<sup>2</sup> Tri+
   PCBs per mass unit
   area
- River Sections 2 and 3
  - 10 g/m<sup>2</sup> Tri+ PCBs
     MPA

Figure 1. The Upper Hudson River (UHR) section, subsection and reach designations.

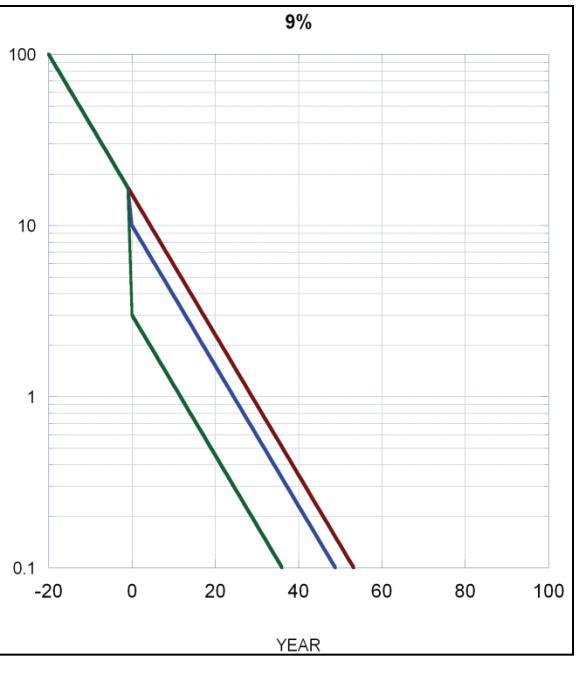
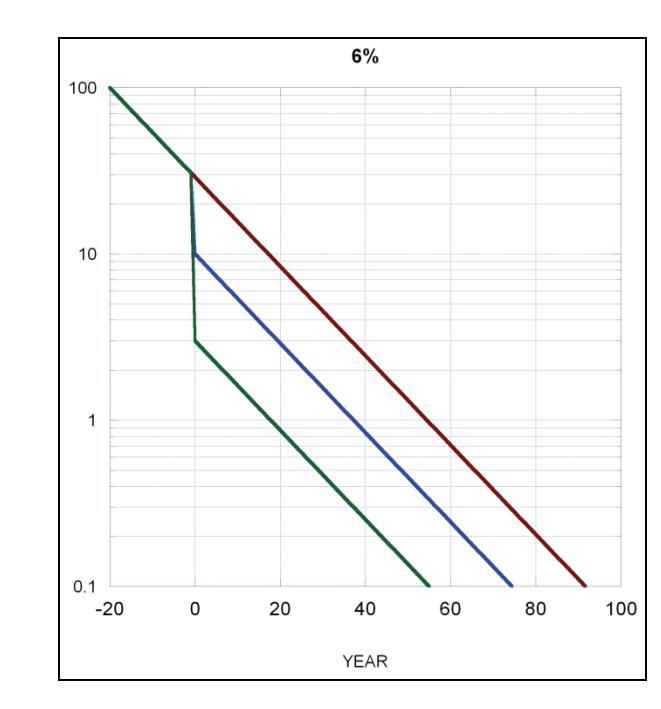
### **Three Assumptions about Recovery Over Time**

-	-	_
Rate of	Natural	10 ppm	3 ppm
Decline	Recovery	Alternative	Alternative
9%	29	25	12
6%	55	38	18
3%	>100	76	37

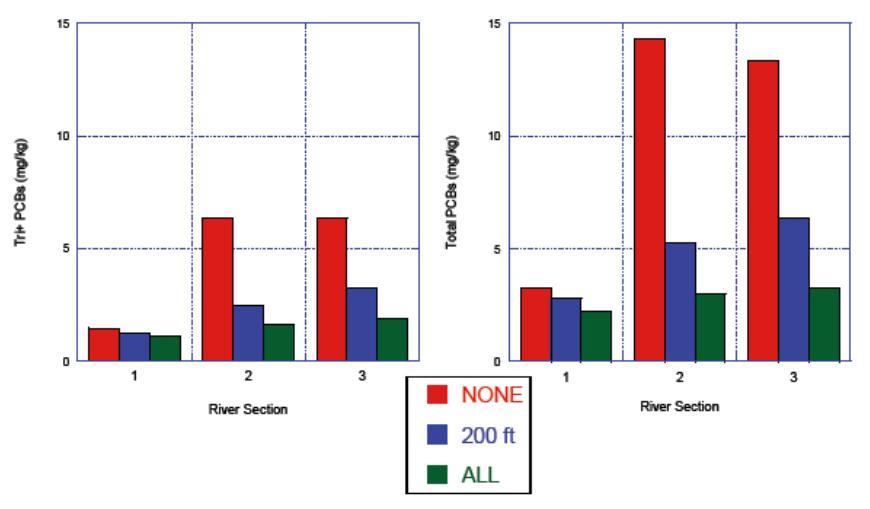
Figure 3. Post-dredging estimated average Tri+ and Total PCB concentrations (mg/kg) in surface sediment by river section under three scenarios: 1) current remedial design; 2) additional removal of cores with surface Tri+ concentration exceeding 10 ppm that are within 200 feet of existing dredge areas; 3) additional removal of all cores with surface Tri+ CB concentration exceeding 10 ppm.

- Applying RS1 surface sediment standards to RS2 and RS3 would
  - Produce a more protective cleanup
  - Require dredging ~136 acres

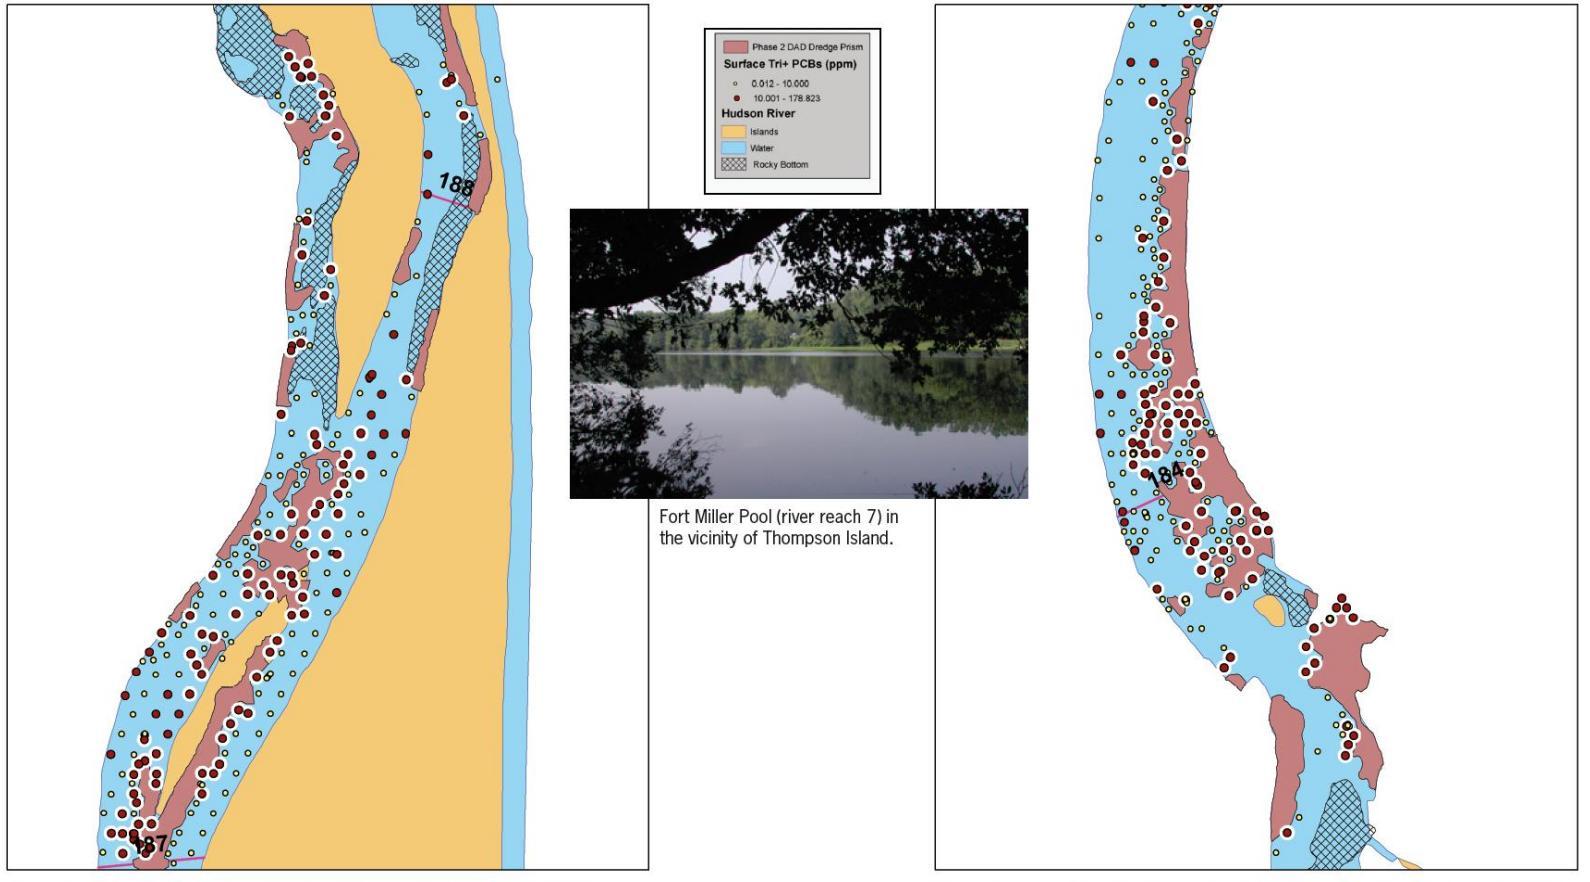
Figure 4. Map of the Upper Fort Miller Pool (River Section 2, river mile 187-8) showing cores outside of Phase 2 dredge prisms that exceed 10 ppm Tri+ PCB (red circles) and are within 200 feet of dredge prism boundary (red circles with white halo).

Figure 5. Map of the Northumberland Pool (River Section 2, river mile 184) showing cores outside of Phase 2 dredge prisms that exceed 10 ppm Tri+ PCB (red circles) and are within 200 feet of dredge prism boundary (red circles with white halo).

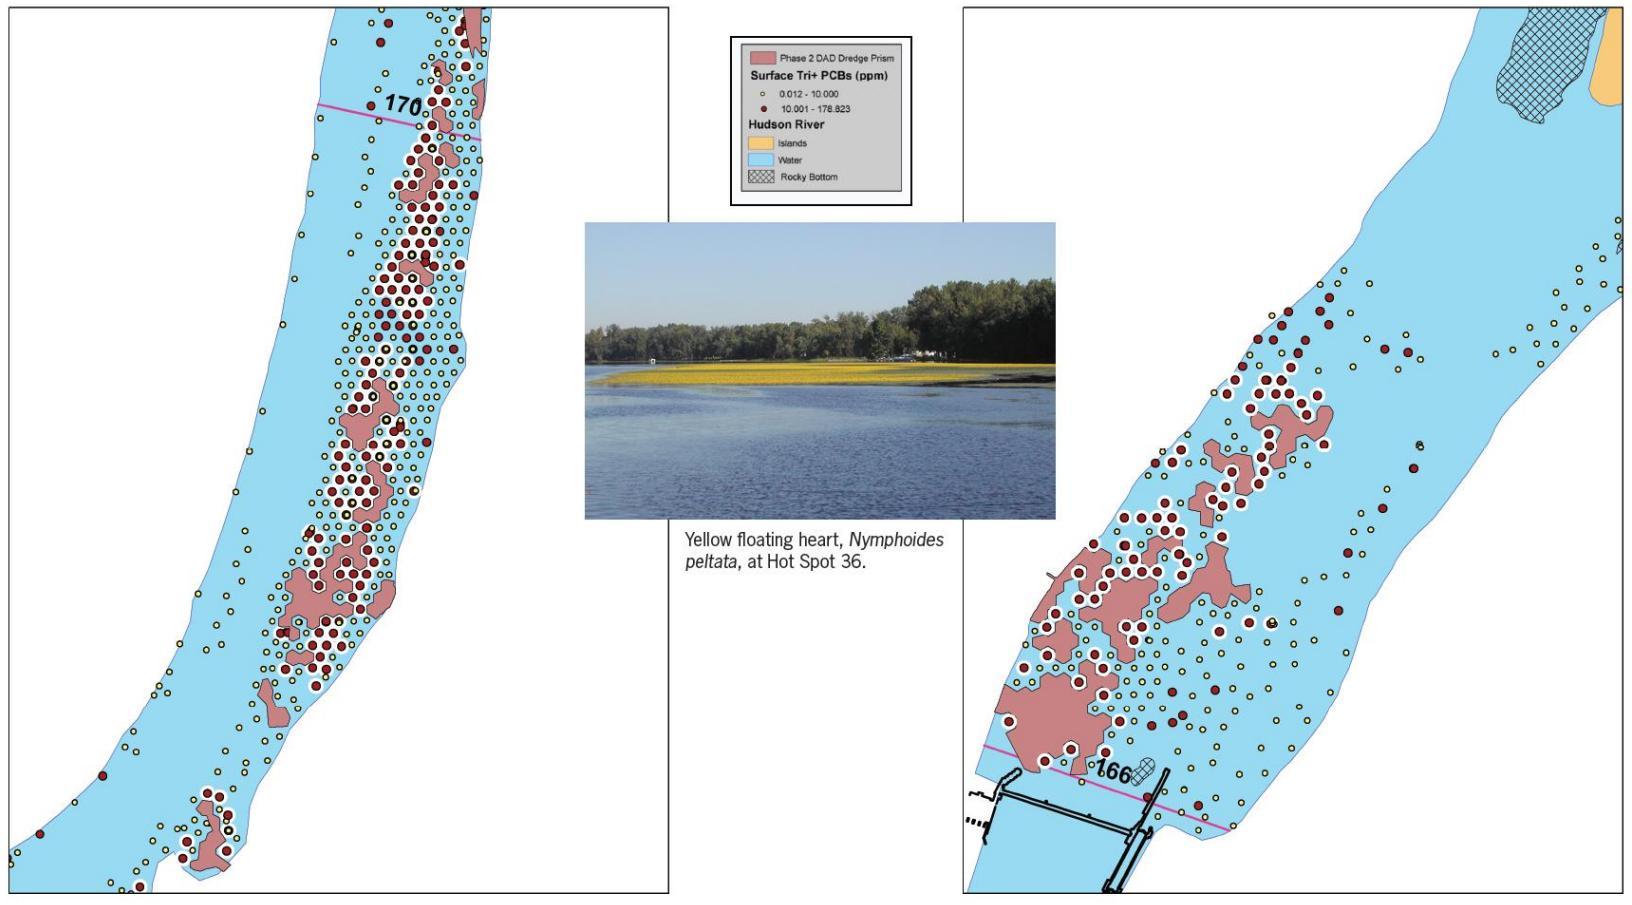
Figure 6. Map of area in the vicinity of Hot Spot 36 (River Section 3, river mile 170) showing cores outside of Phase 2 dredge prisms that exceed 10 ppm Tri+ PCB (red circles) and are within 200 feet of dredge prism boundary (red circles with white halo).

Figure 7. Map of area in the vicinity of Hot Spot 37 (River Section 3, river mile 166) showing cores outside of Phase 2 dredge prisms that exceed 10 ppm Tri+ PCB (red circles) and are within 200 feet of dredge prism boundary (red circles with white halo).
