# FALL KILL WATERSHED NEIGHBORHOOD SOURCE ASSESSMENT

**A survey of pollution potential  
and restoration opportunities**

Prepared in 2012-2013, by Hudson River Sloop  
Clearwater and the Fall Kill Watershed Committee

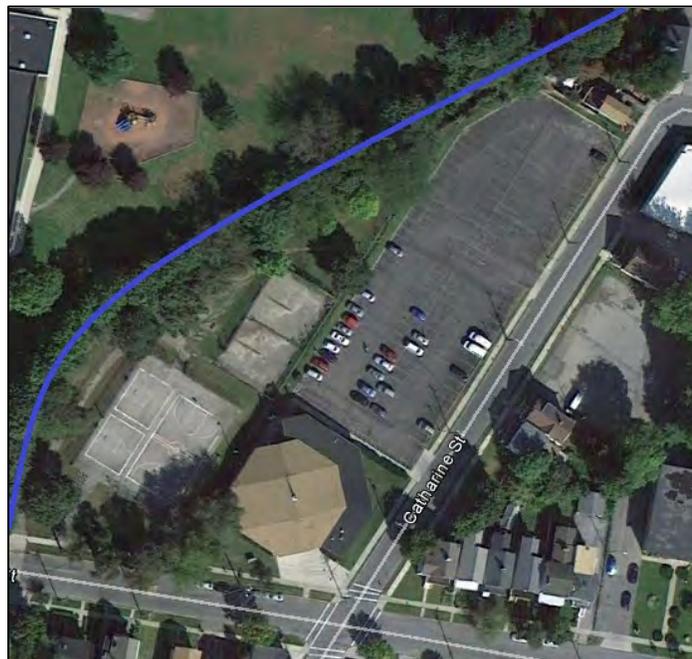
**Beulah Baptist Church in NBD 28 presents an excellent opportunity for a parking lot bioswale.**

This type of green infrastructure practice would be appropriate for parking lots in the City of Poughkeepsie. There are numerous parking lots throughout the City, some of which are located in the assessed neighborhoods. For example, Beulah Baptist Church on Catherine and Mansion Streets is a large impervious surface that directly abuts the creek. A wetland/bioswale could be installed here, with the DEP example as a model.

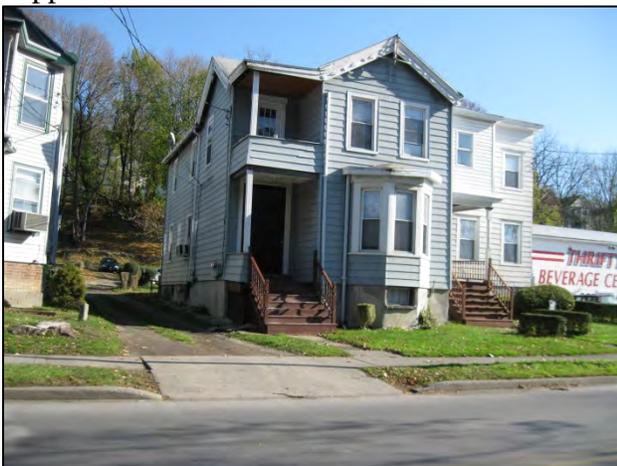
There are numerous areas in the assessed neighborhoods in Poughkeepsie that have restoration potential for tree planting. Neighborhoods 26 and 27 are just two examples offered below. Conflicts with overhead and subsurface utilities must be considered when siting new trees, but those two considerations notwithstanding, Poughkeepsie has a wealth of tree planting opportunities.

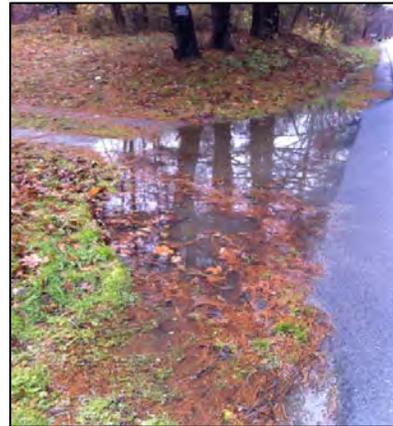
**Flooded Dirt Driveway**

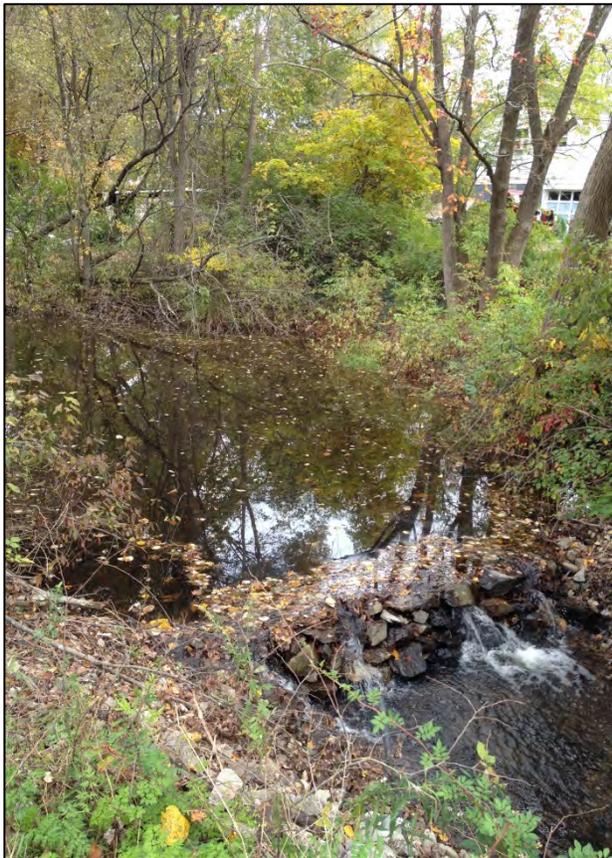
Other issues worth noting in the neighborhood include an artificial dam, which appears to have been constructed by the resident at 10 Quaker Hill Drive. While perhaps pleasant for the resident, a dam such as this can contribute to water quality issues by disturbing natural flow and increasing water temperatures, which can lead to aquatic species impairment.

**The dam constructed at 10 Quaker Hill Drive**

On a second visit to the neighborhood, the resident explained that the town had removed the dam after Hurricane Irene, but that he put it right back up. This conflict between the town and the landowner should be addressed promptly, and in a non-threatening manner. A mediator such as the CAC or a local organization like Clearwater or Dutchess County Cornell Cooperative Extension could potentially help the process come to a mutually agreeable conclusion.

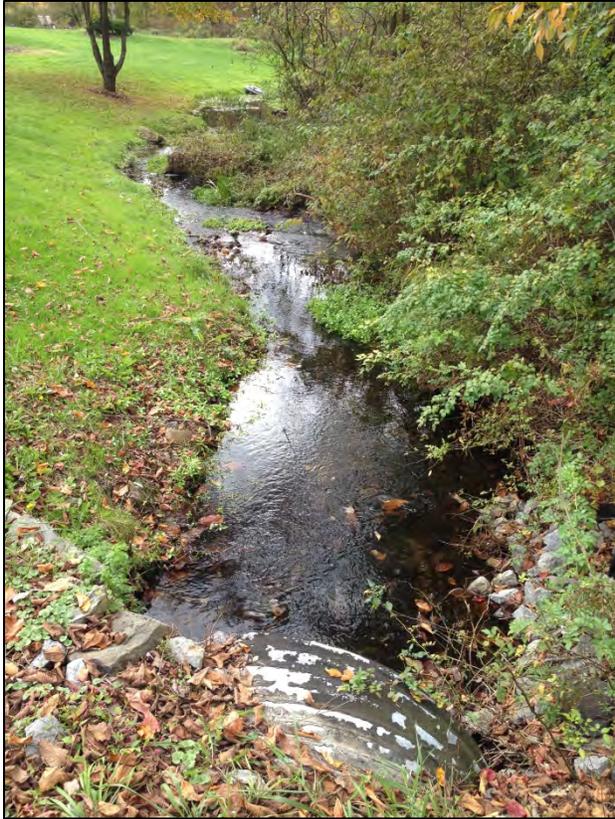
**Culvert opposite the dam on Quaker Hill Drive**

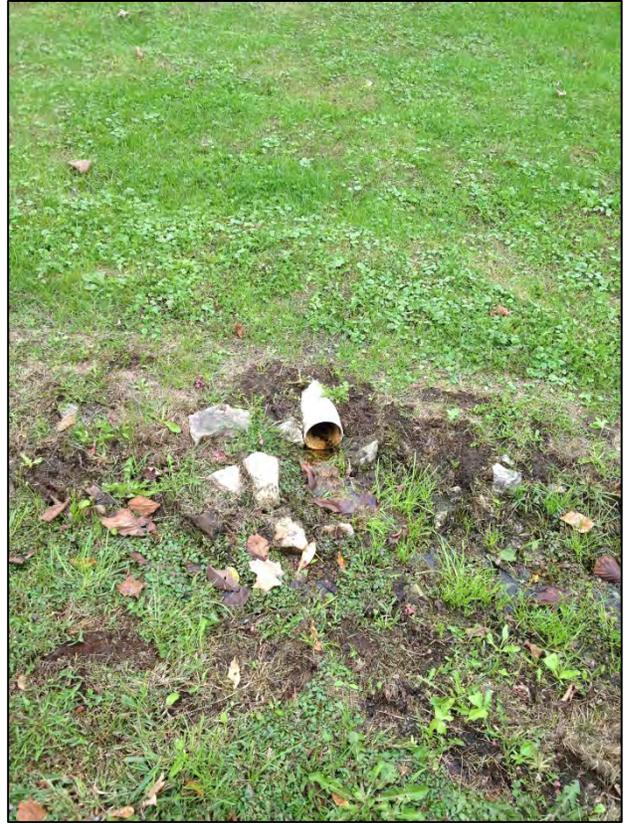
**Buried pipe carrying roof rainwater to roadside ditch**

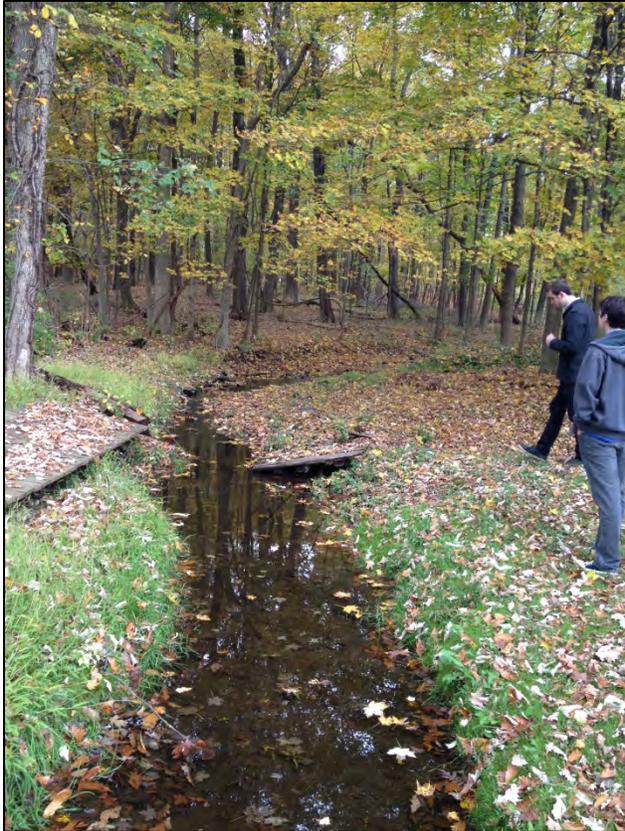
Flooding issues appear to be a problem for some residents and perhaps offer another restoration opportunity. Alfred Jiava, homeowner of nearly thirty years at 28 Quaker Hill Drive, reported considerable flooding in his backyard during recent years. An unnamed stream that flows south across his property has reportedly started flooding only in recent years and most recently pushed waters close to his home.

Stream behind 28 Quaker Hill Drive, looking north

Mr. Jiava stated that when he purchased the property he removed several trees in the rear yard, which may contribute to flooding issues. However, he stated that flooding has only been an issue in recent years, suggesting the stream is receiving increased volume, perhaps from increased development in nearby neighborhoods further upstream. Mr. Jiava's property also had a culvert installed on the northern edge of the property (see photo), which appears to receive stormwater from Quaker Hill Drive. Additional water volume from this culvert could also be contributing to increased water volume in the stream and flooding issues. Short of a hard-engineered berm or levee, perhaps some sort of bioswale could be constructed in Mr. Jiava's backyard that could act as a sort of spillway to capture water before it approaches his home.

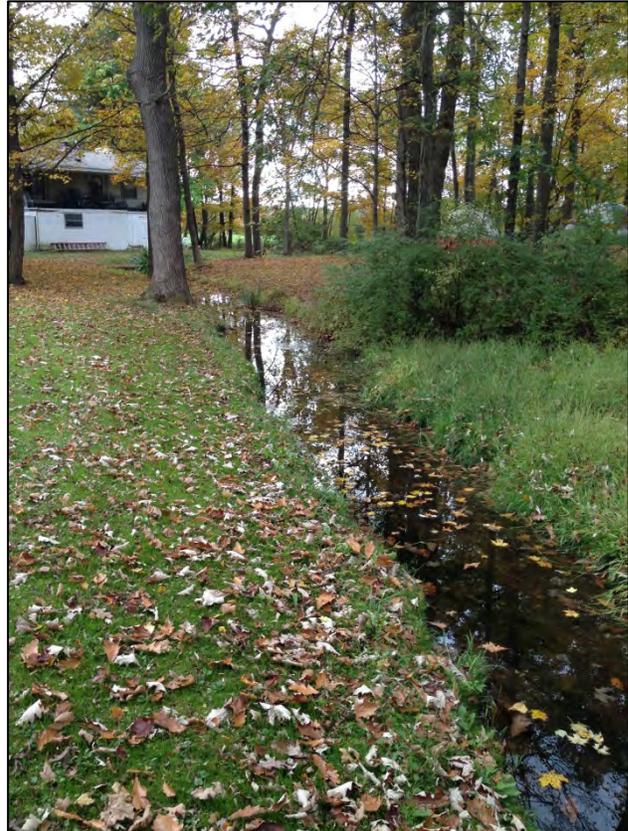
Stream behind 28 Quaker Hill Drive, looking south

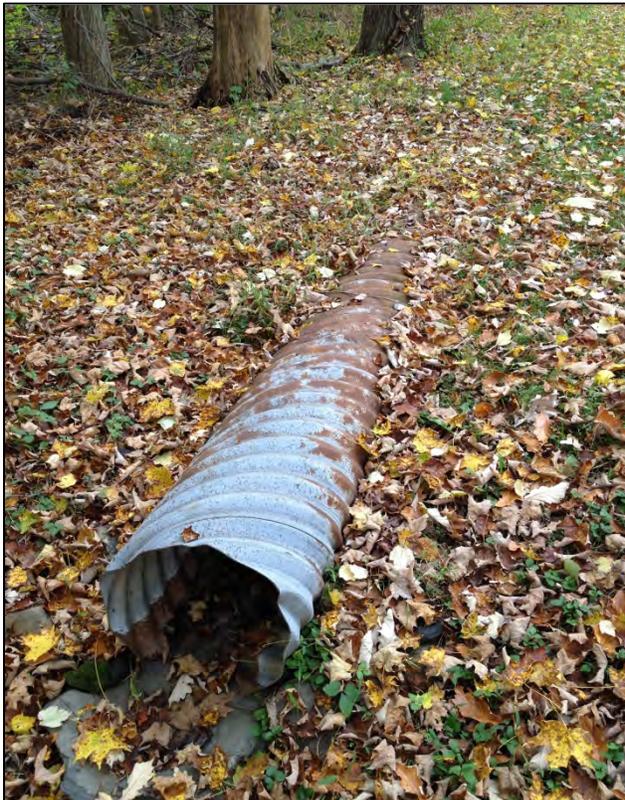
Culvert leading to stream, 28 Quaker Hill Drive

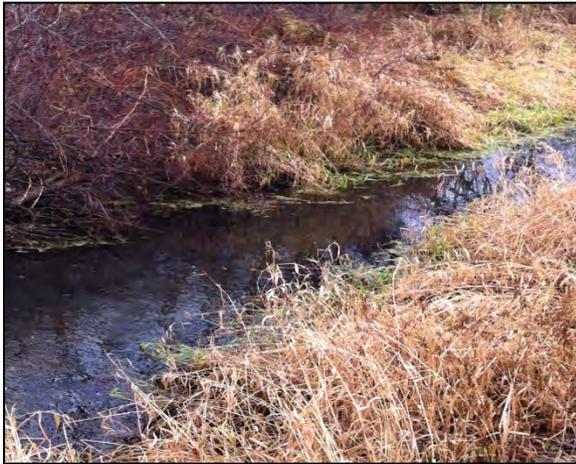
**Algae in the creek across the road**

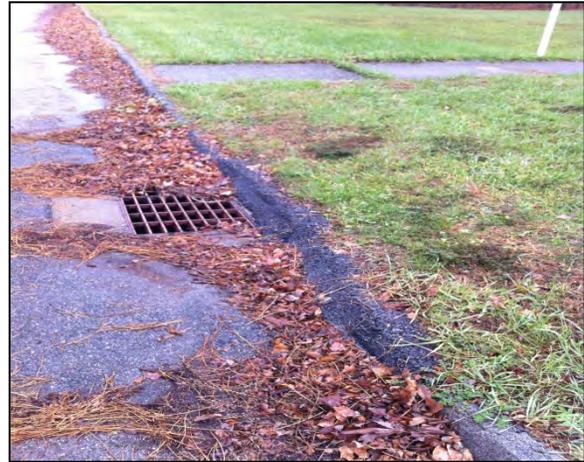
**Storm drain with organic matter build up**

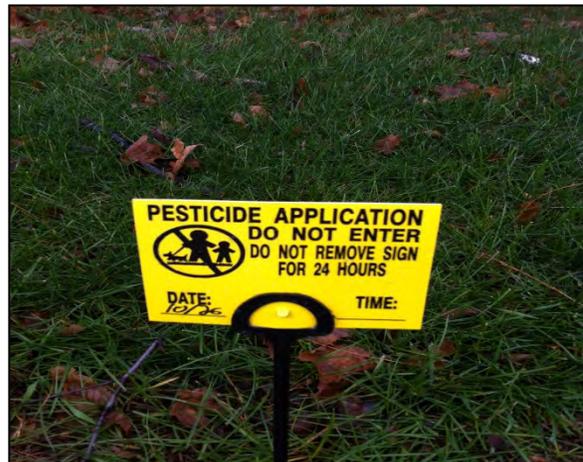
The biggest pollution threat in the neighborhood is the high standards for lawn maintenance. Additionally, there is evidence of pesticide use on the lawns at one house (see photo below), and it seems likely that other property owners may also follow this example.

**Pesticide sign on a lawn, dated 10/26**

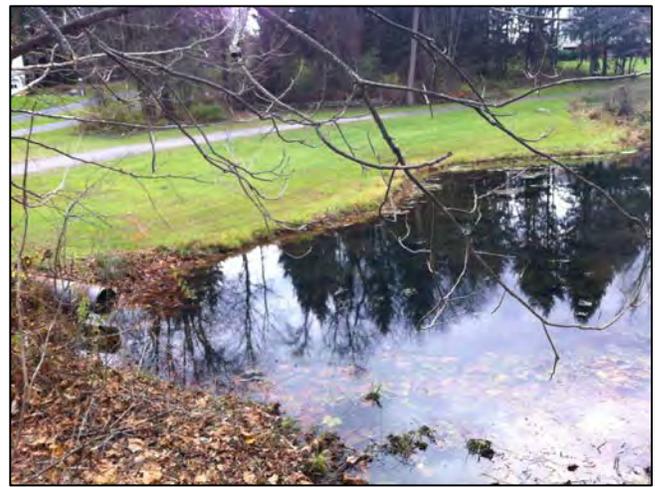
**Storm pipe leading into creek**

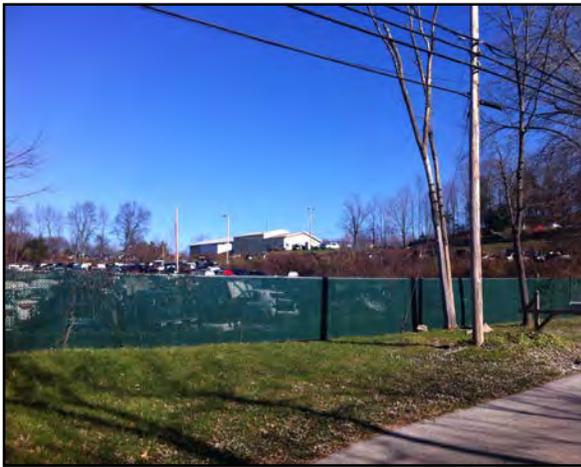
Tributaries of the Fall Kill Creek course both throughout and adjacent to this large neighborhood. Most homes appear to be well kept, some with extensive landscaping. Stormwater appears to be well managed through a system of storm drains likely leading to nearby wetlands. The most notable feature about the neighborhood is the presence of an auto body shop on the northern border of the neighborhood. The shop, located off of Rogers Road, is on a hill, and the autos are exposed to the elements, increasing the risk of pollution runoff to the tributaries.

**Auto shop off of Rogers Rd.**

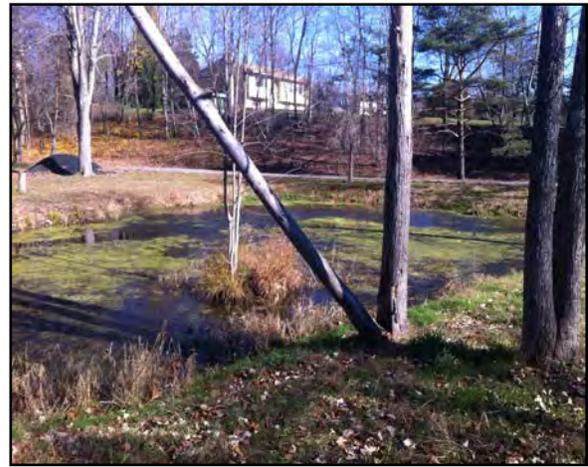
There are several ponds in the neighborhood, and there is some noticeable algae in one of the ponds, hinting at an excess of nutrients. Canada geese were observed at another pond, on private property, and they may frequent multiple locations in the neighborhood. Waste from Canada geese can contribute to fecal coliform loading in the creek. Plants could be introduced here and landscaping practices could be changed to stop possible runoff of fertilizer.

**Pond with evidence of algae**

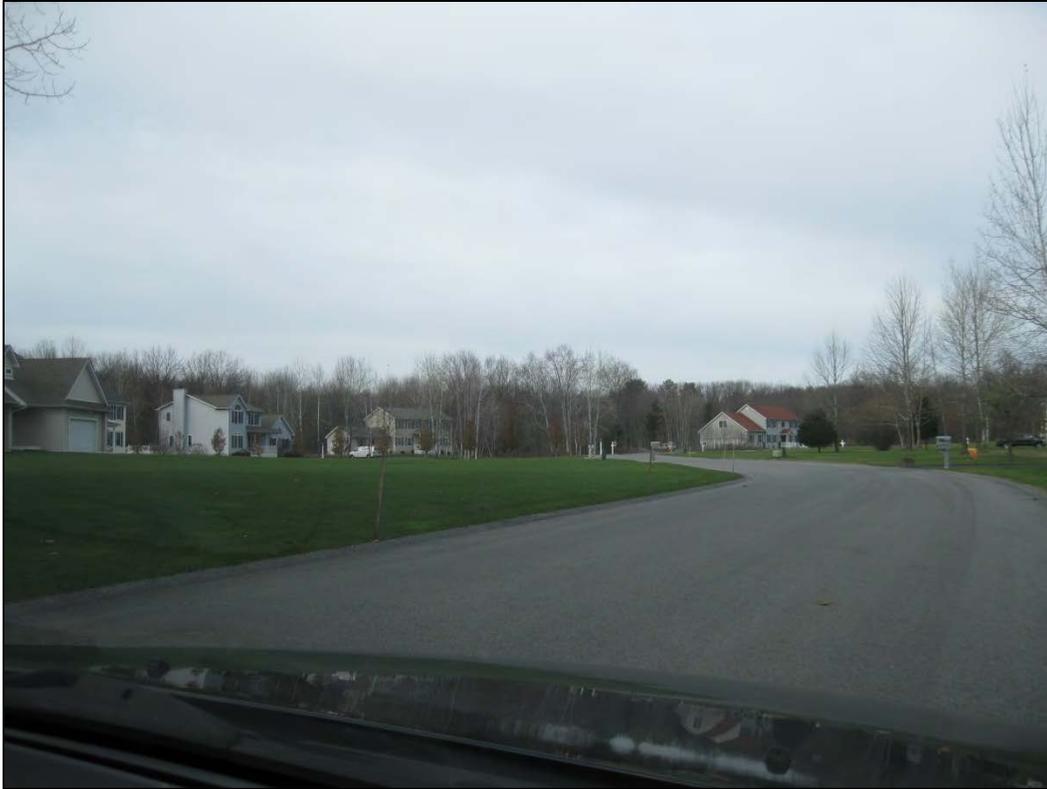
Neighborhood 7 needs to be divided into sub-neighborhoods, including 7A and 7B, in order to better assess the impact on the watershed. 7A consists of two cul-de-sacs, Meyers Lane and Bellas Way, on the northwest corner of the map. This area is generally low contributing in terms of pollution. While there is high management intensity of lawn turf and likely fertilizer use, there appears to be a well-kept buffer of wetlands between the homes and the stream, likely preventing pollutants from entering the waterway. The biggest restoration opportunity in this area would be to simply plant more trees. This area was clearly forested prior to development, but now many lots, particularly on Bellas Way, have bare front yards that could use more trees (see photo).

**Bellas Way, in need of trees**

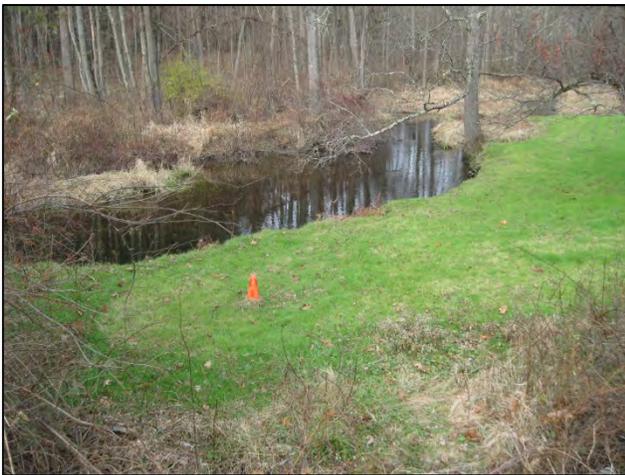
The 7B section of this neighborhood is located on either side of Haviland Road. These areas generally do well maintaining a good riparian buffer between lawn and stream, with only a few exceptions (see photo). The culverts at road crossings appear to be sufficient to handle the considerable volume of water that passes through this neighborhood (see photo).

**Lawn cut to stream edge**

Restoration opportunities here would include ensuring proper riparian buffers are maintained at all segments of the stream. Lawns cut to the stream edge, such as shown in the photo above, can invite Canada geese to occupy the area next to the stream, leading to increased fecal coliform loading from geese excrement.

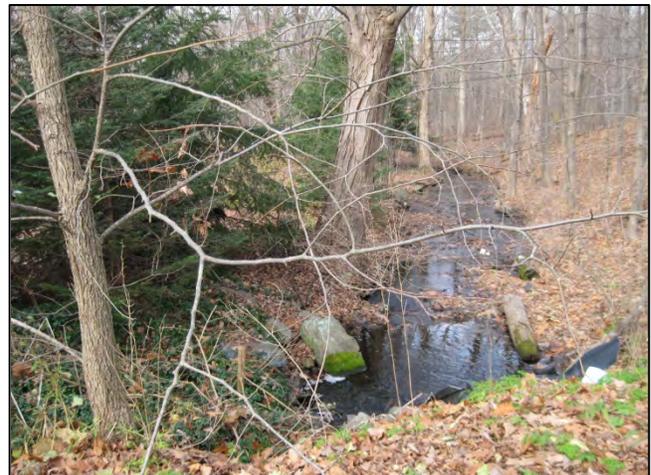
**Stream and culvert at Haviland Road**

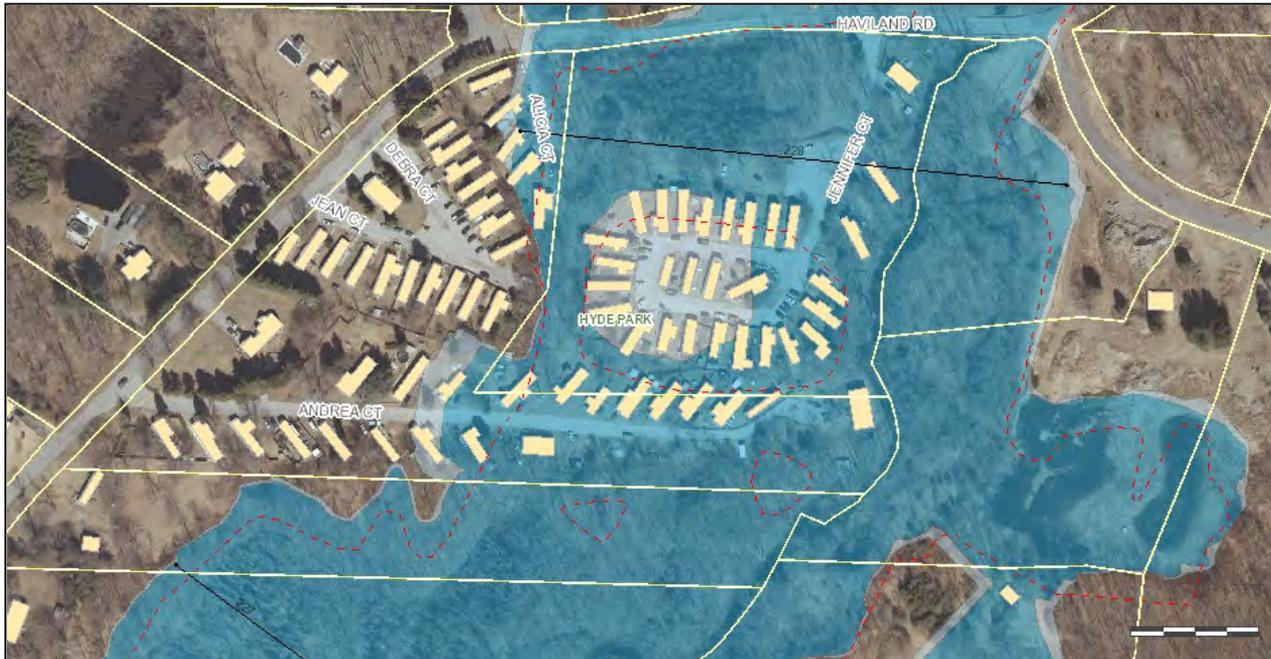
This neighborhood is very much defined by its topography and proximity to the Fall Kill. Most of the park is located well within the 100 year flood plain, as seen below.

**FEMA's new DFIRM map displaying the current 100 year floodplain.**

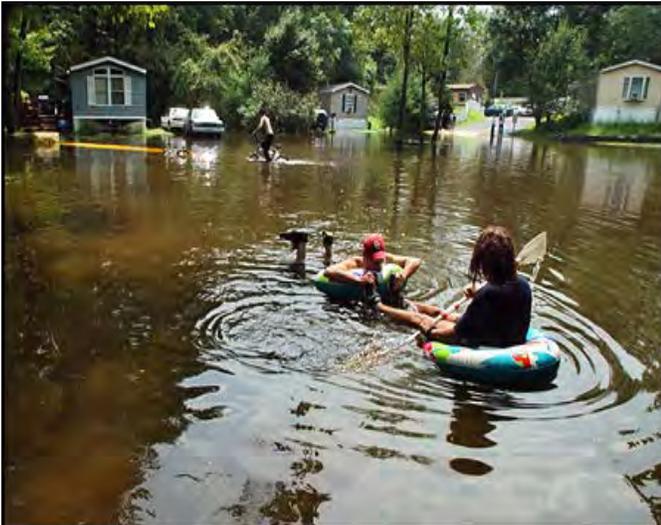
*The residential area between Haviland Road and Roosevelt Road experienced severe flooding and damage caused by heavy rainfall (see photo). The soils within and along the banks of the creek in that area, Sun and Carlisle, are both considered very poorly drained, while the soil throughout the surrounding residential area, Hoosic, is very well drained. Impervious surfaces associated with suburban and rural development increase the rate and volume of runoff and compound the flooding problem.*

**Flooding along Haviland Road in 2003**

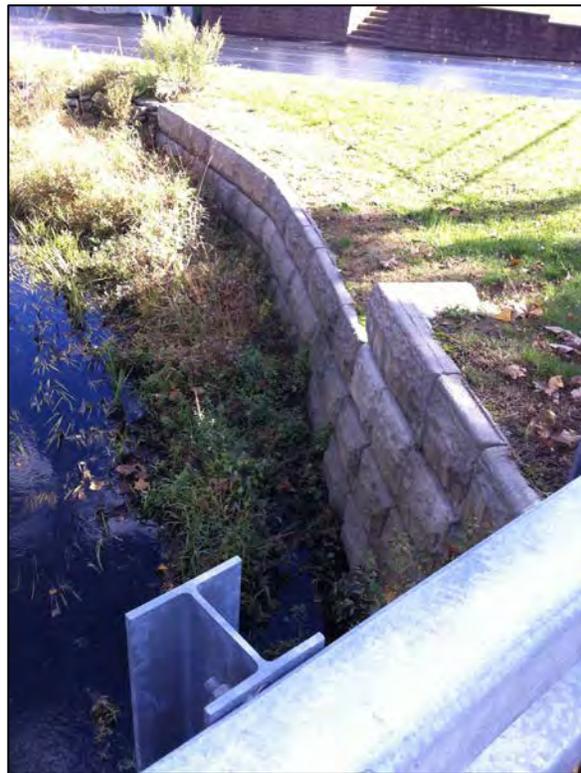
**Retaining wall along the creek**

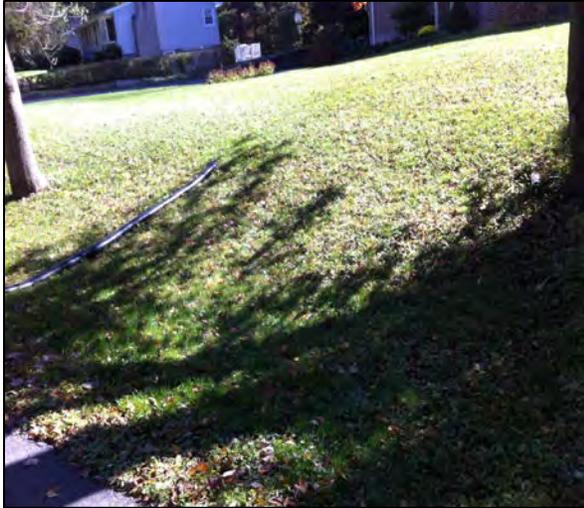
The Fall Kill Creek winds significantly through this neighborhood and intersects several roads, making it more vulnerable to fertilizer runoff from nearby homes and pollution from the street (car runoff and litter). However, the neighborhood is well maintained with significant landscaping along the creek. Most areas have rocks along the banks in addition to plant vegetation. Some riparian areas along the creek could be better treed (see photo below). Certain areas of the neighborhood had significant amounts of tree cover, which can provide protection from the sun and rain. No sprinkler systems were observed in the area. Most houses are higher in elevation, with downspouts draining onto either the lawn or driveway, and then flowing down into the street. This water then flows into the storm drain inlets in the roads, which lead directly to the creek.

**Typical drain flowing from house to street, Haviland**

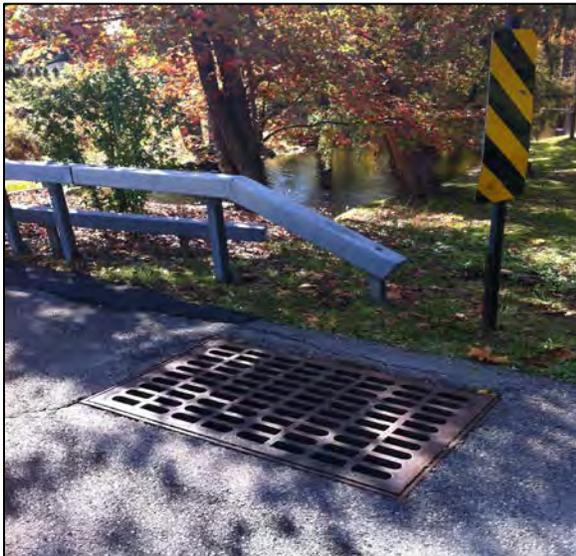
**Typical storm drain inlet near creek, Haviland**

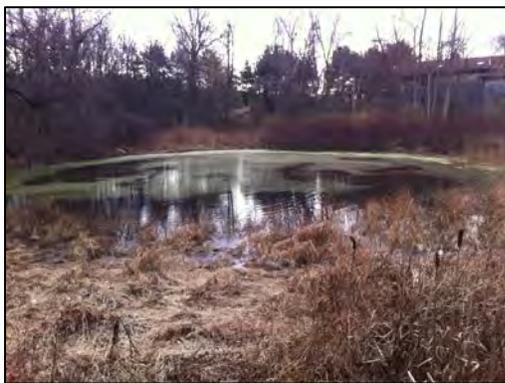
The creek runs through several yards and intersects the busier streets frequently. This poses a greater threat for stormwater runoff, and could be fixed by better landscaping practice on the sides of the creek. Also noticeable are three vegetative and well-manicured stormwater ponds interspersed throughout the neighborhood. However, all three lie next to busy roads, one in the southwest corner off Cream Street; another on the western edge off Beck Road; and another in the northwest corner off Dutchess Hill Road. All three are wet ponds, with only one (on Dutchess Hill Rd.) displaying signs of algae.

**Pond with algal growth off Dutchess Hill**

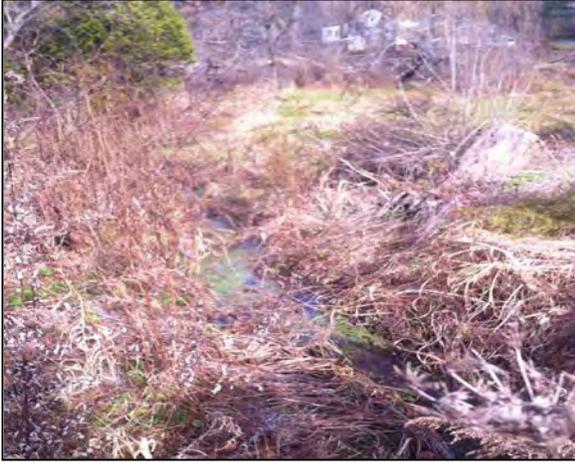
**Algae in Creek**

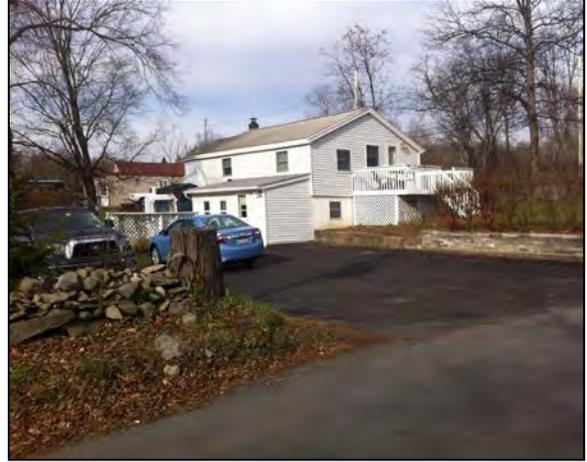
**Home with driveway downspouts**

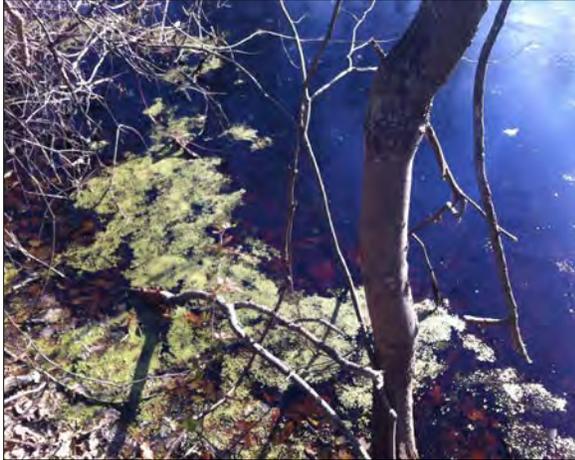
**Algae in the large pond**

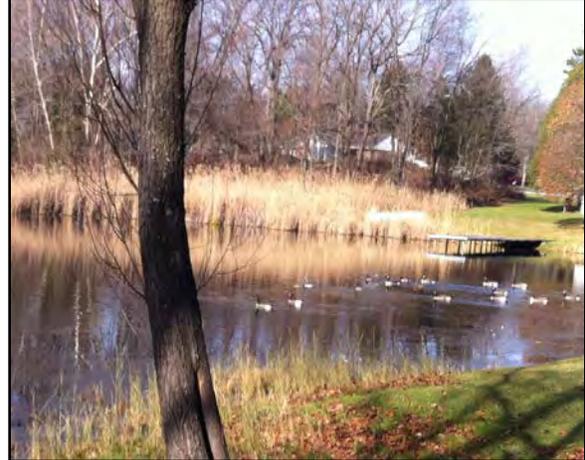
**Canada geese in the large pond**

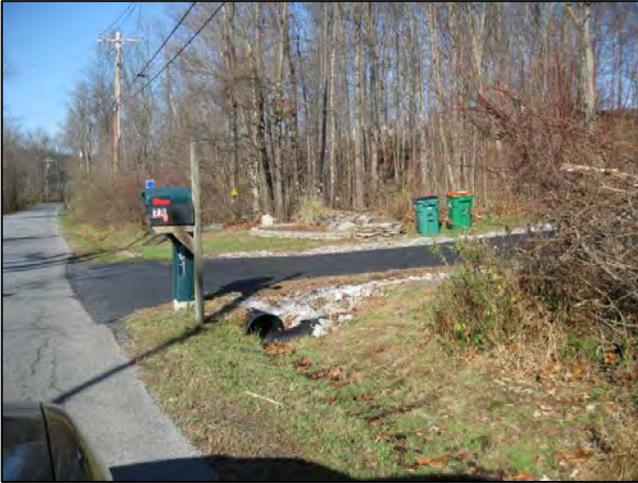
**16Culvert at 78 Peach Road**

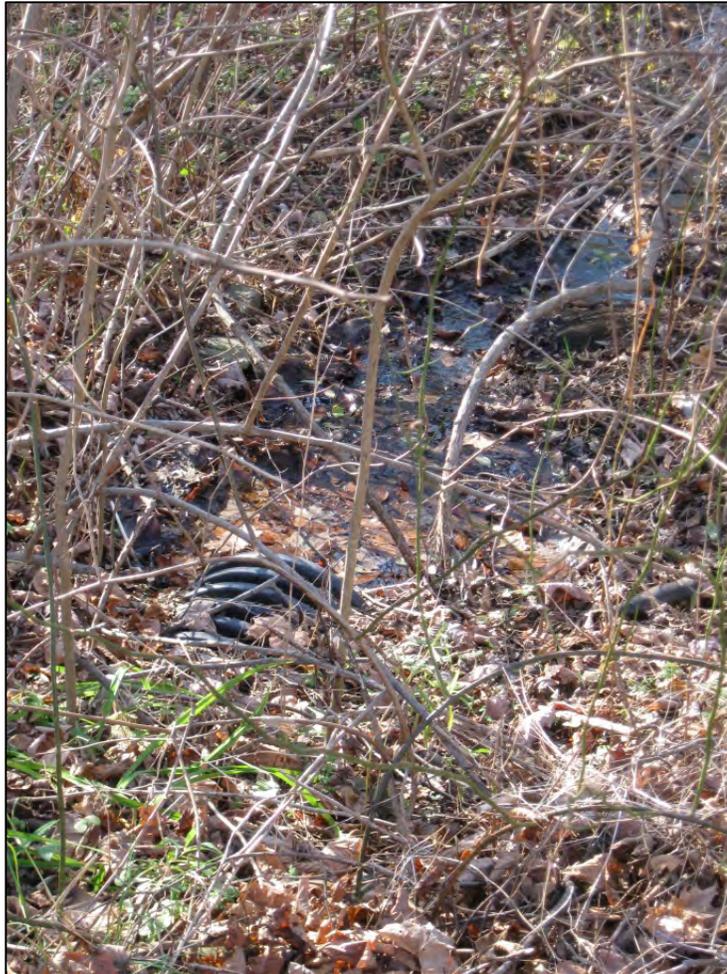
**Stormwater directed to wetland**

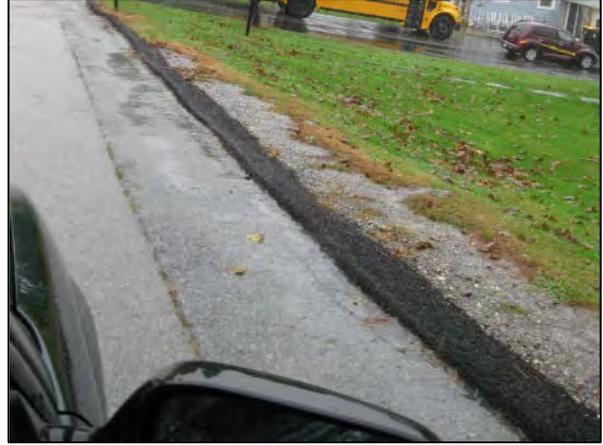
**Asphalt berm on Pells Court**

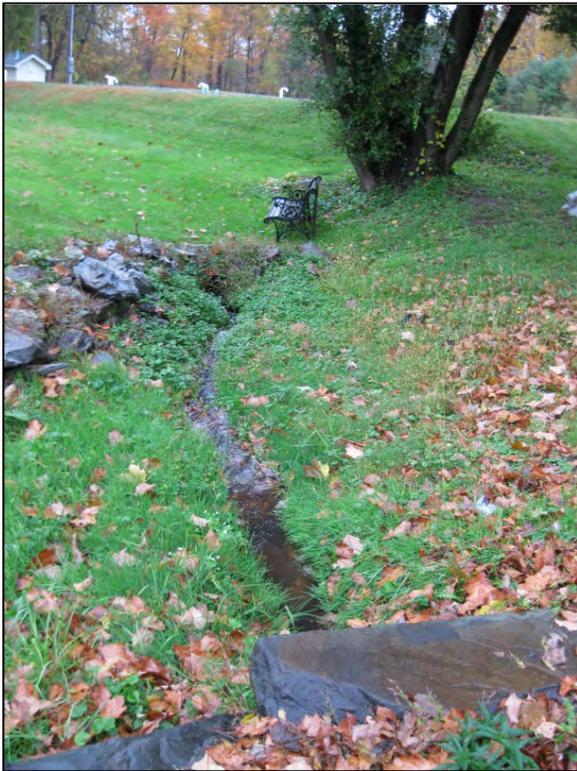
**Stormwater stream at 34 Bircher Ave.**

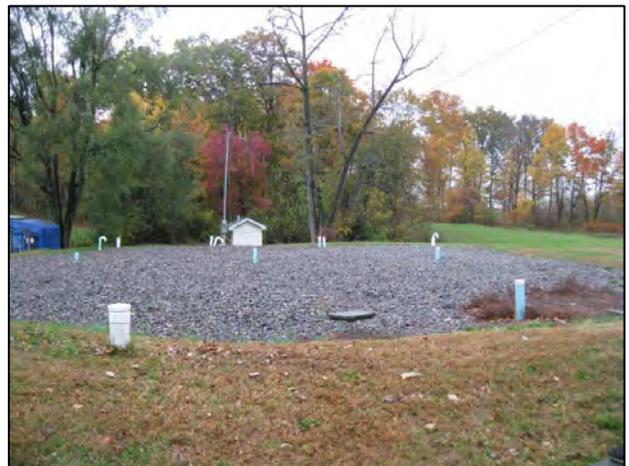
Also notable, the Valley Forge mobile home park has a community sewer system that drains into a large leach field on the south side of Bircher Avenue (see photo) next to 34 Bircher Avenue – the property that experiences periodic flooding – ultimately into an unnamed stream per SPDES permit renewed in February 2012. The siting of a leach field for a mobile home community in an area prone to flooding seems problematic and a potential health hazard.

**Leach field for mobile home park**

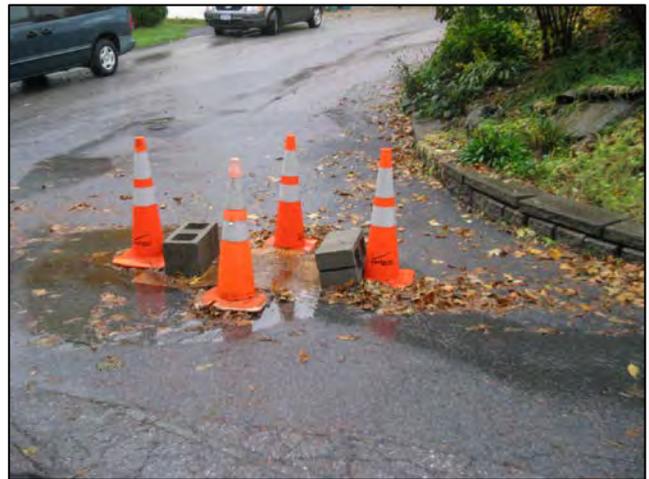
**Storm drain with no cover**

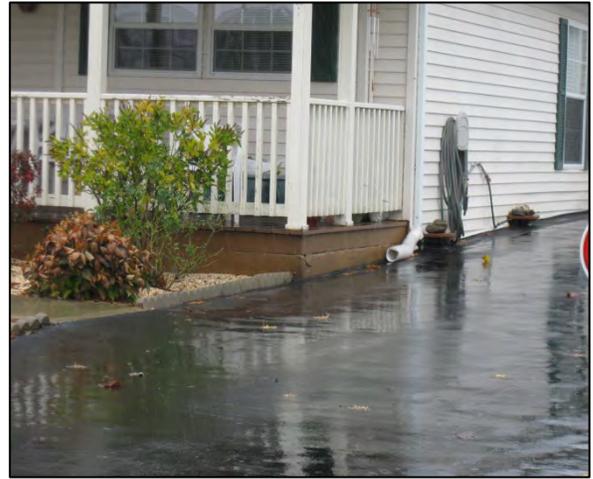
**Downspout directed to driveway.**

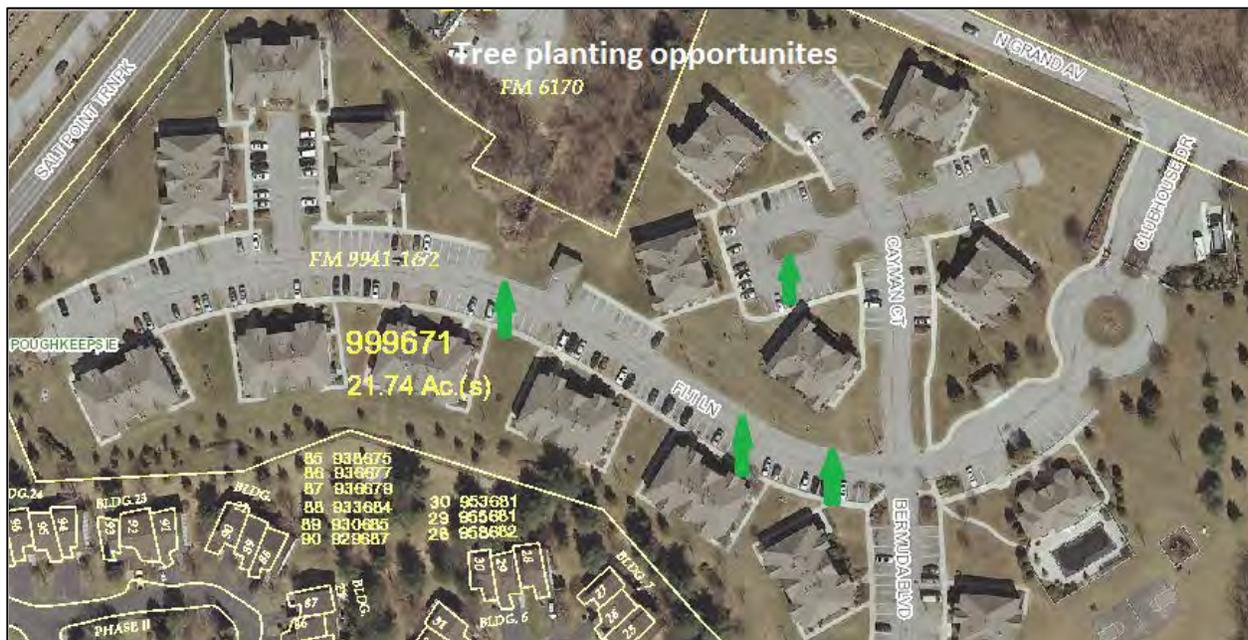
Numerous tree planting opportunities along Fiji Ln. and Cayman Ct., site C, Grand Point Park Apts

Grand Point Park Apartments (C), the northern most site in Neighborhood 20, also represents relatively low pollution potential. While roughly two-thirds of the complex is impervious, nearly all roof rainwater is directed to pervious lawn areas. The greatest restoration opportunity would be to plant more trees around the complex, particularly areas next to the road on Fiji Lane and grassy islands around Cayman Court. Tree canopy can help capture and evapotranspire rainwater, preventing it from entering the stormwater system.

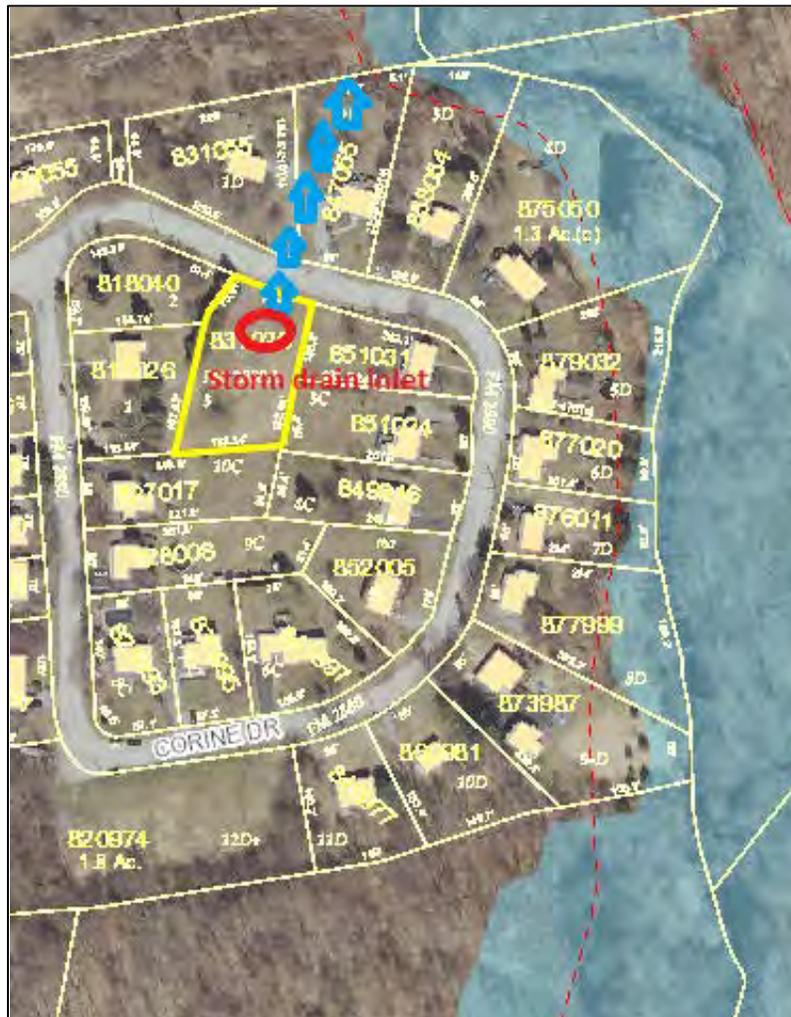
One interesting feature of the neighborhood is an open space area (highlighted in map) that bisects the neighborhood from north to south (see map). A storm drain was observed to the west of 8 Corine Drive, which perhaps was installed to deal with flooding issues and appeared to be connected to a culvert that extends for some length south, judging from the depression in the ground (see photo). This may be a good location for some type of bioretention area, which could help trap and filter any pollutants from stormwater runoff that are enter the system and discharge into the creek.

**Storm drain inlet and flow direction north, with 100 year flood plain to the east**

Another recommendation would be to stencil all storm drain inlets to inform residents that drains discharge into the creek.

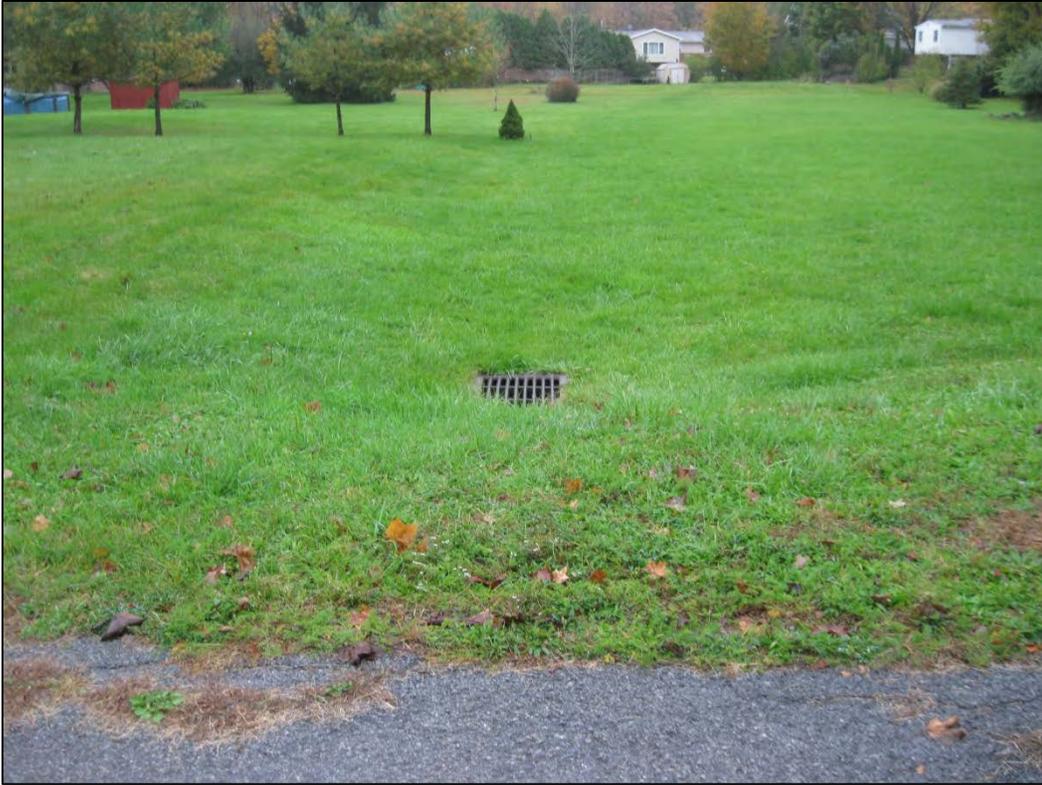
**Possible location for bioretention area, near 8 Corine Drive**

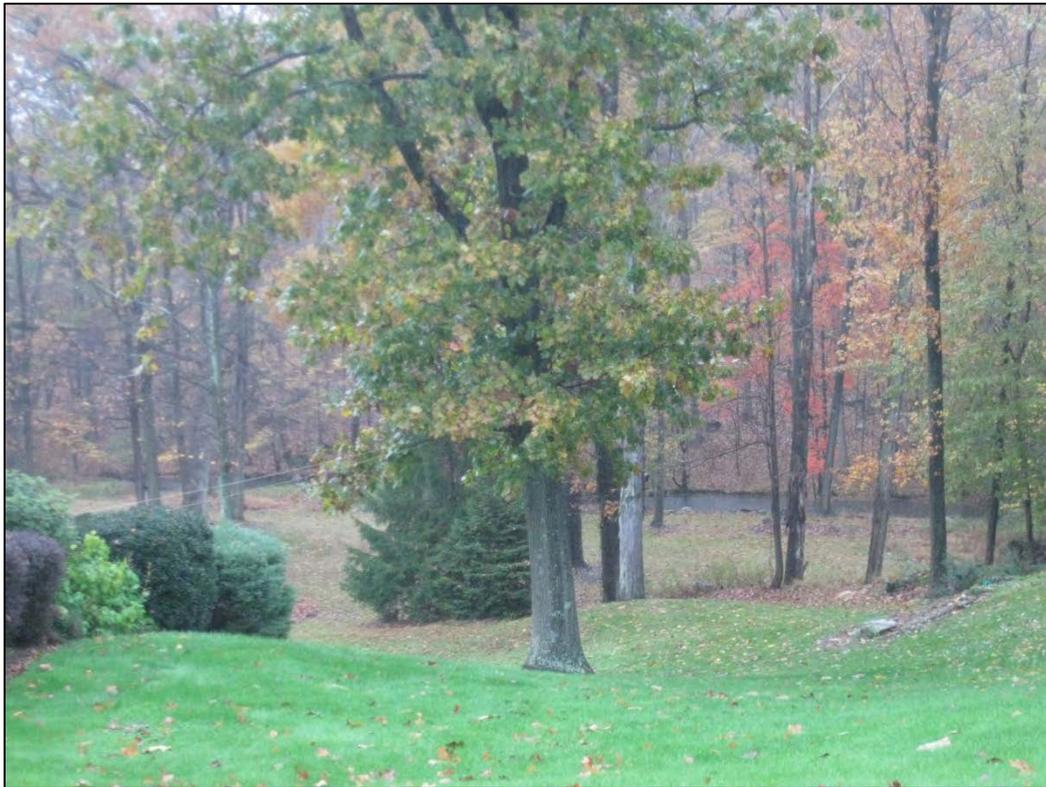
**Example of good riparian buffer, eastern edge of neighborhood**

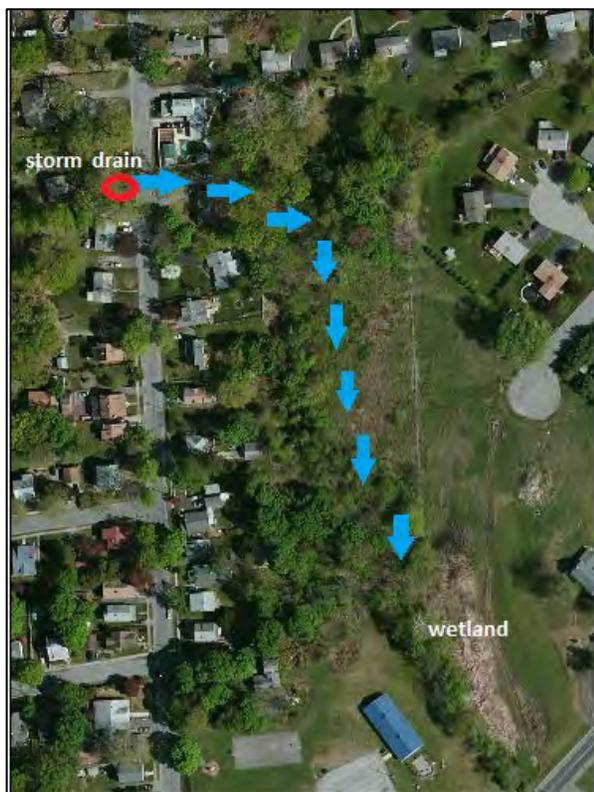
**Water flow from storm drain to wetland off Sophia's Way**

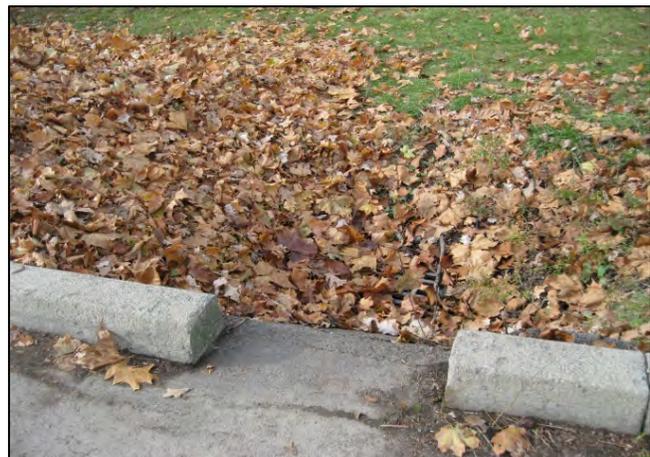
Stormwater appears to be well managed, with nothing extraordinary standing out. The exception to this would be on Oakdale Avenue where stormwater is directed via curb cut to a storm drain and then culverted from the west side of the street (see photo), between 103 and 91 Oakdale Avenue, under the street to what appears to be an intermittent stream (see photo). The stream channel cuts between 102 and 92 Oakdale Avenue and heads east to a wooded area. Water from this wooded area likely flows south to a wetland (see photo) which can be accessed at the end of Sophia's Way.

**Curb cut/storm drain west side of Oakdale Ave**

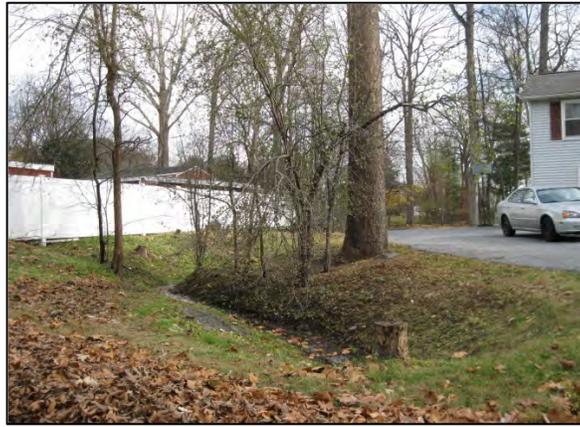
**Stream bed east side of Oakdale Ave.**

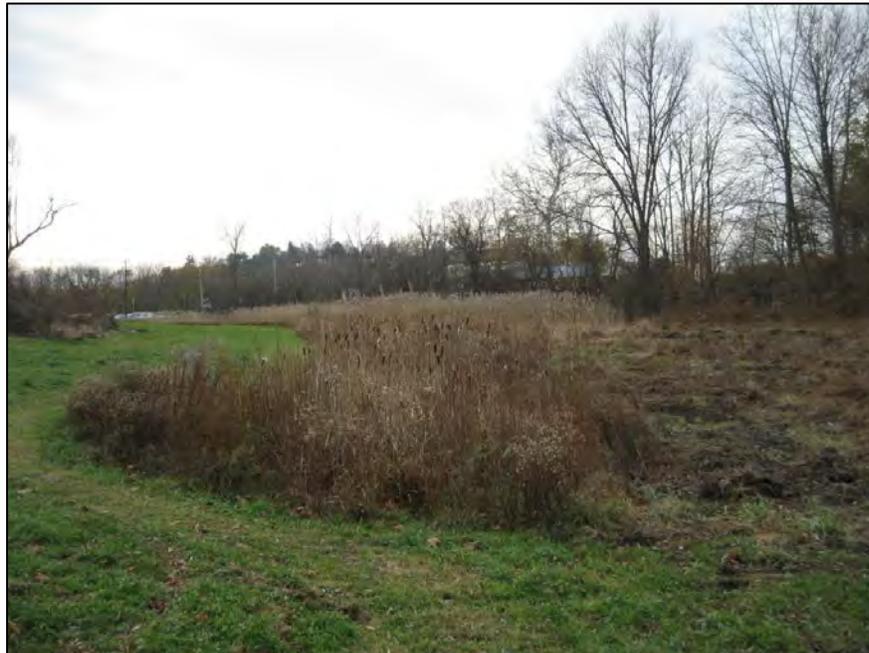
**Wetland off of Sophia's Way**

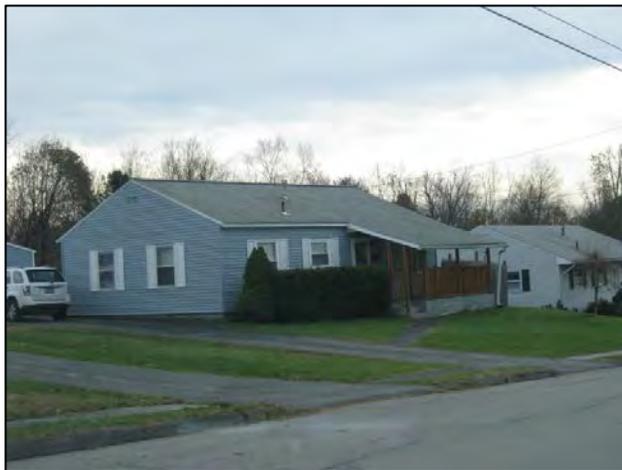
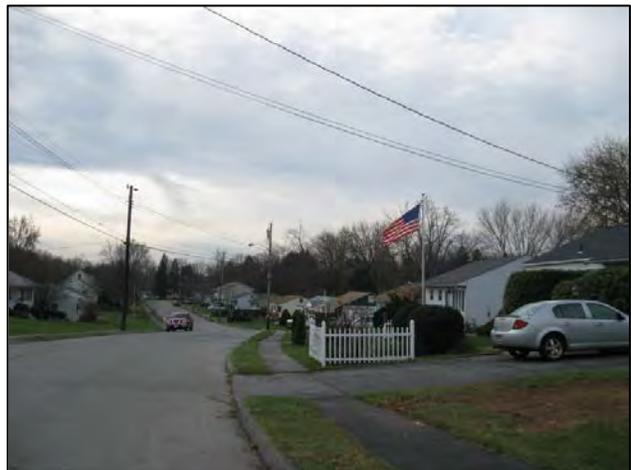
**Tree planting opportunities in the northern section of the neighborhood along Peter Cooper Drive**

Neighborhood 23 as a whole is considered to have low pollution potential and low restoration potential. The neighborhood feels fully built out in terms of density and is generally well treed, although some of the northern streets have room for potential street trees, particularly around Peter Cooper and Van Wyck Drives (see photo).
