# FALL KILL WATERSHED NEIGHBORHOOD SOURCE ASSESSMENT

**A survey of pollution potential  
and restoration opportunities**

Prepared in 2012-2013, by Hudson River Sloop  
Clearwater and the Fall Kill Watershed Committee

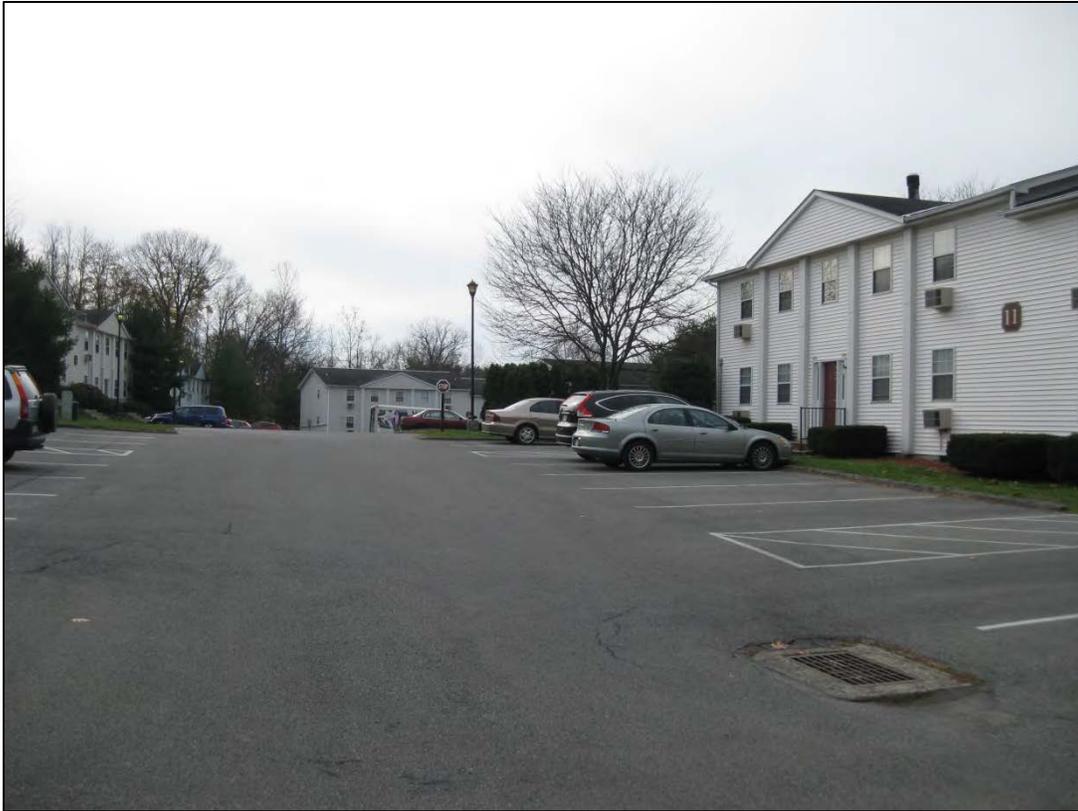
This complex, which seems to be an effective use of space in terms of density, appears to handle stormwater onsite rather than directing to a waterway. Most roof leaders drain to pervious areas, and stormwater from the parking lots drains to storm drains with deep catch basins, which may act as dry wells; no discharge area from any storm drain could be observed.

**Parking lot and storm drain, Colonial Manor**

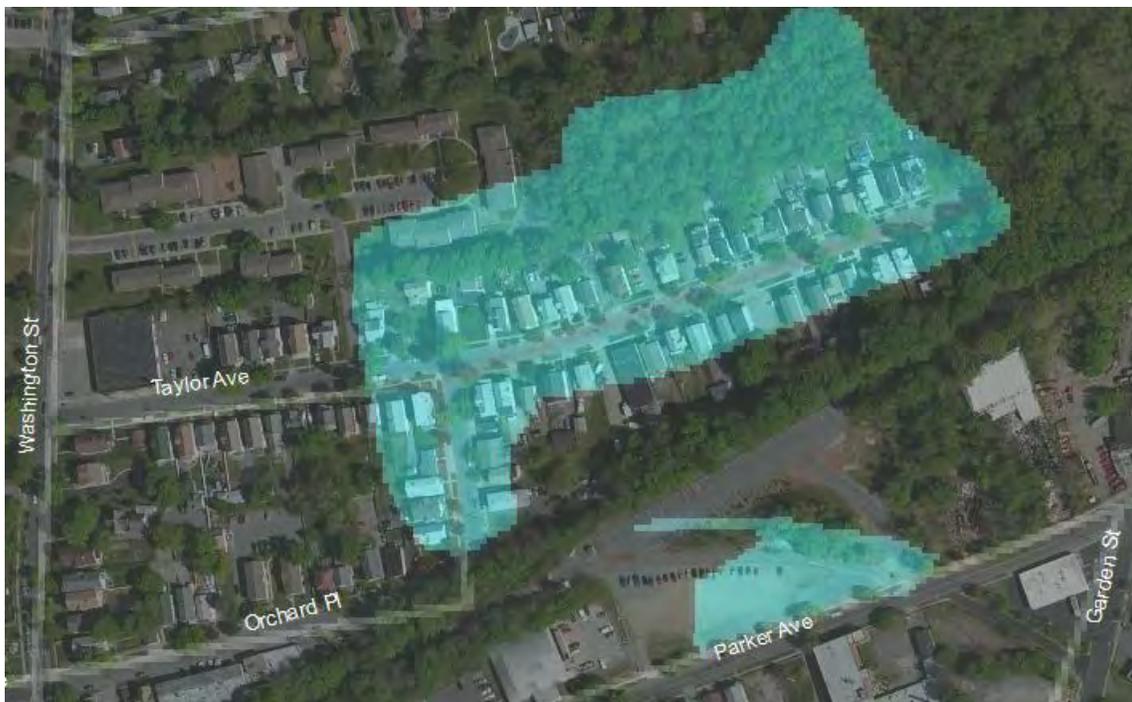
Capturing as much stormwater before it enters storm drain inlets is particularly important in the eastern portion of the neighborhood, especially on Taylor Avenue, since this is one of the City of Poughkeepsie’s known combined sewer locations (see map). Combined systems carry both stormwater and sanitary waste, and during wet weather events can quickly become overwhelmed and discharge untreated wastewater into the Fall Kill Creek.

The blue area represents the combined sewer drainage boundary on Taylor Avenue

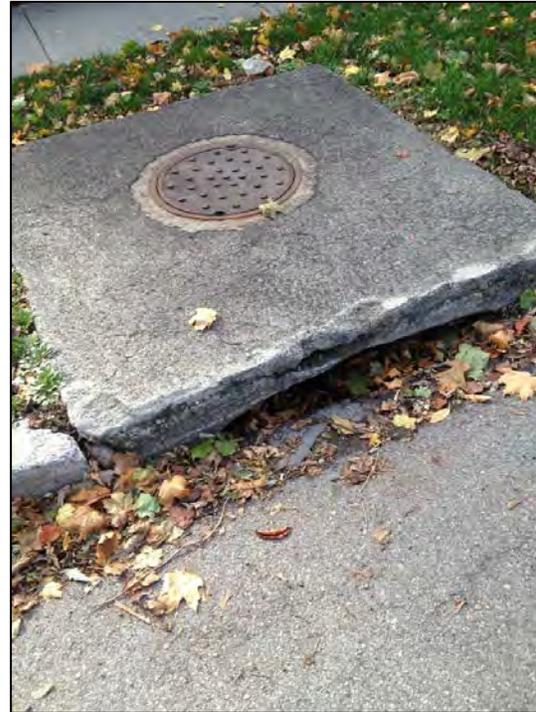
**Combined drain, Taylor Avenue**

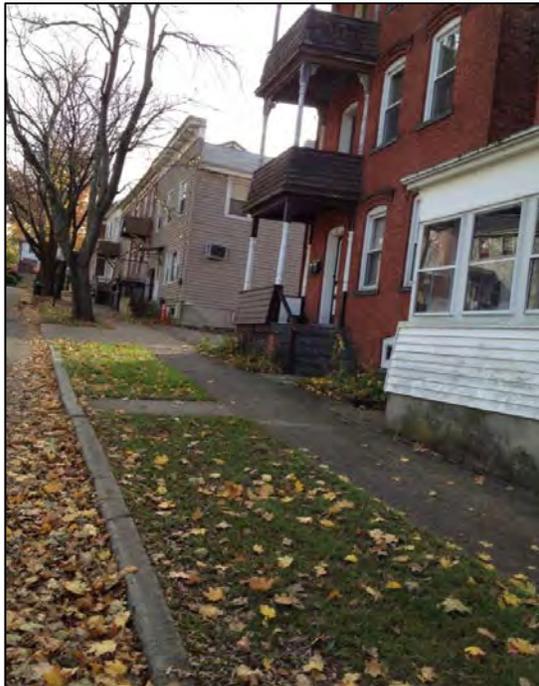
**Room for more street trees.**

Overall, many streets, including Winnefield, Taylor, Duane, and others, have good sized common areas between the curb and sidewalk that would allow for tree planting opportunities (see photos) and/or curb cuts to direct stormwater to a right-of-way bioswale (see appendix for ROW swale BMPs). In terms of other restoration opportunities, most lots are too small for rain gardens but do have back and/or side yards that might be suitable for rain barrels.

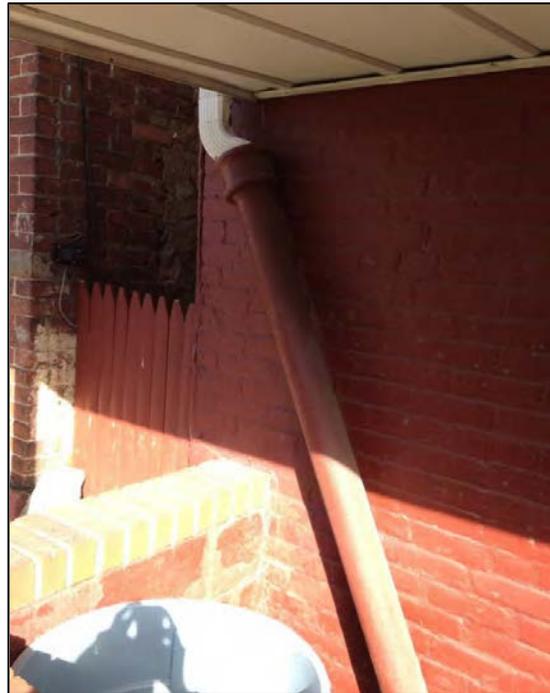
**Direct connect to combined sewer.**

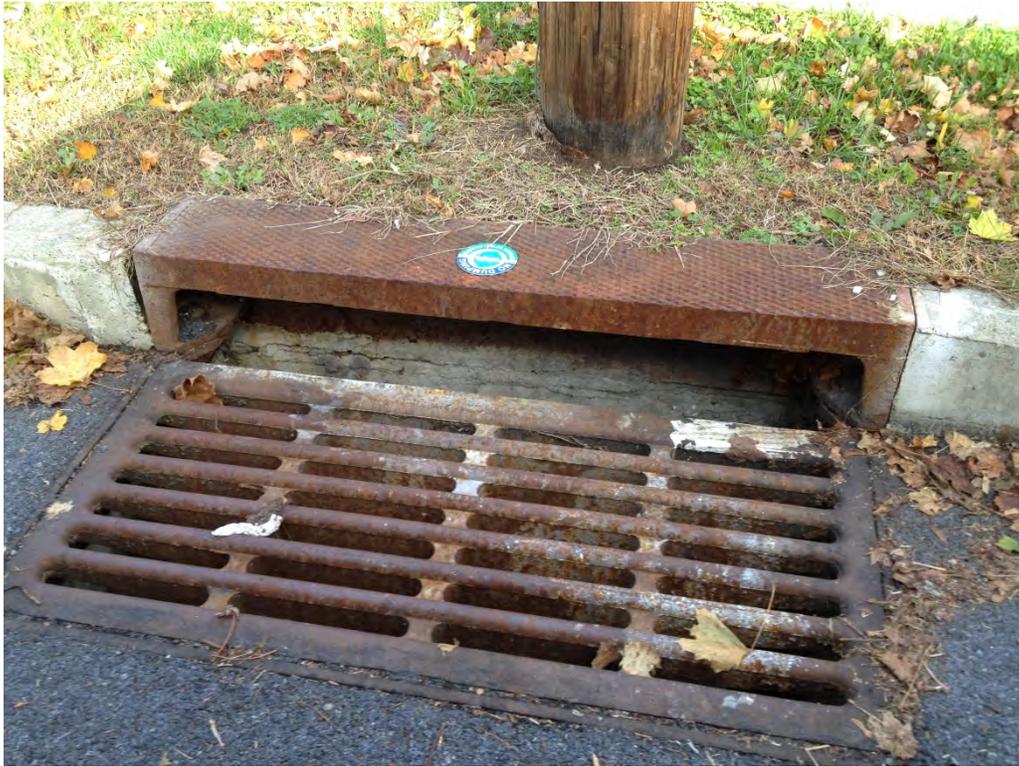
Other recommendations include stenciling all storm drains within the neighborhood. Storm drains west of Washington Street, which tend to be newer, are all stenciled (see photo), however, east of Washington Street, especially Taylor Avenue, are not stenciled. All storm drains had varying amounts of organic matter (mostly Fall foliage debris) and some amount of litter.

**Storm drain west of Washington Street with "Drains to Waterway" decal**

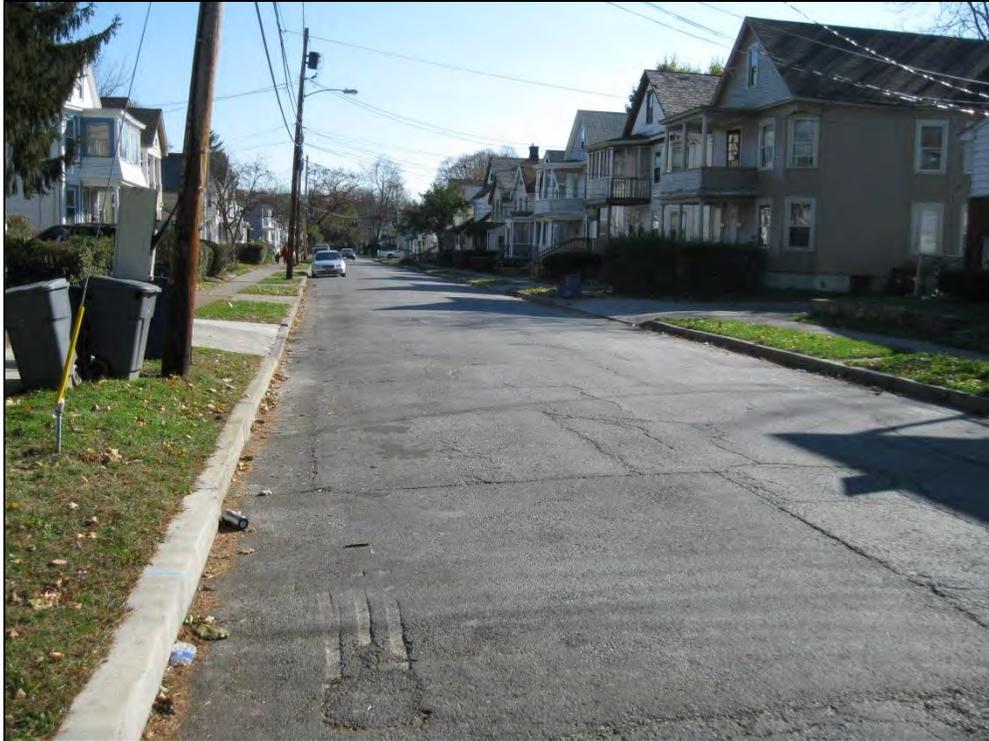
**Typical street in neighborhood 27, with room for street trees or ROW swales**

While the neighborhood has smaller lot sizes, most properties have sufficient space for rain barrels and possibly even rain gardens. These would also aid in taking more stormwater out of the sewer system, helping to prevent CSO events. Another restoration opportunity would be to install Streetside Infiltration Swales or Enhanced Tree Pits, which are typically installed in the right-of-way (ROW) along sidewalks and have the ability to detain large amounts of stormwater, either slowly releasing the water into the sewer system or allowing direct infiltration into the ground. These urban stormwater systems are being tested in larger cities such as Seattle, Portland, New York, and Philadelphia, and have shown promising results (see appendix for BMPs regarding ROW swales).

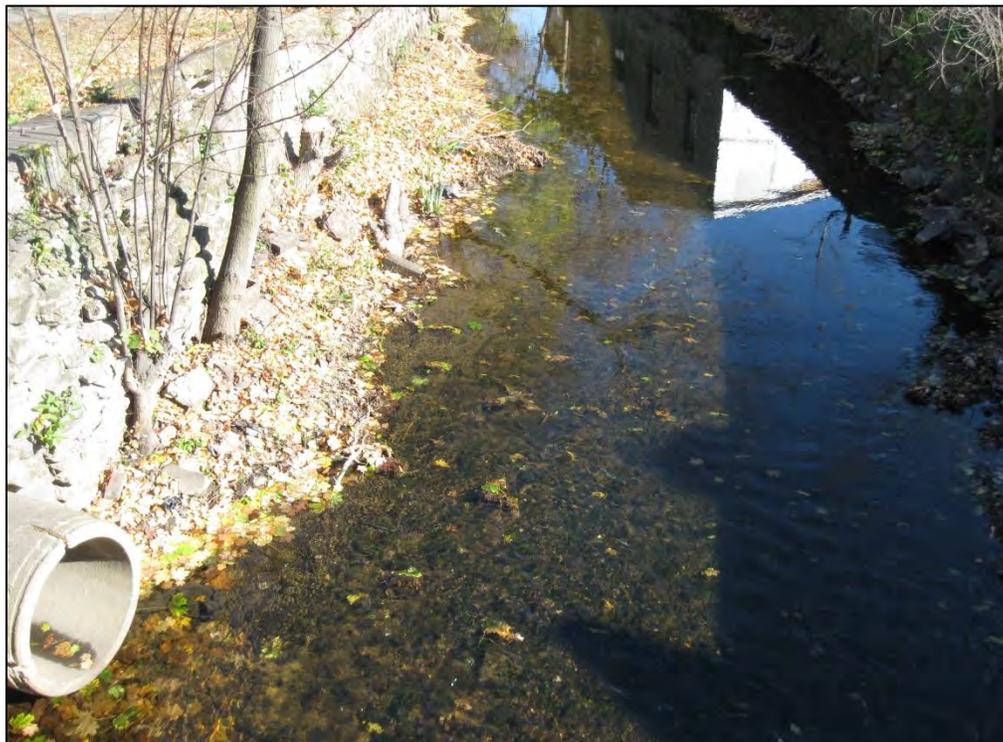
**One of many outfalls along the Fallkill Creek in neighborhood 27**

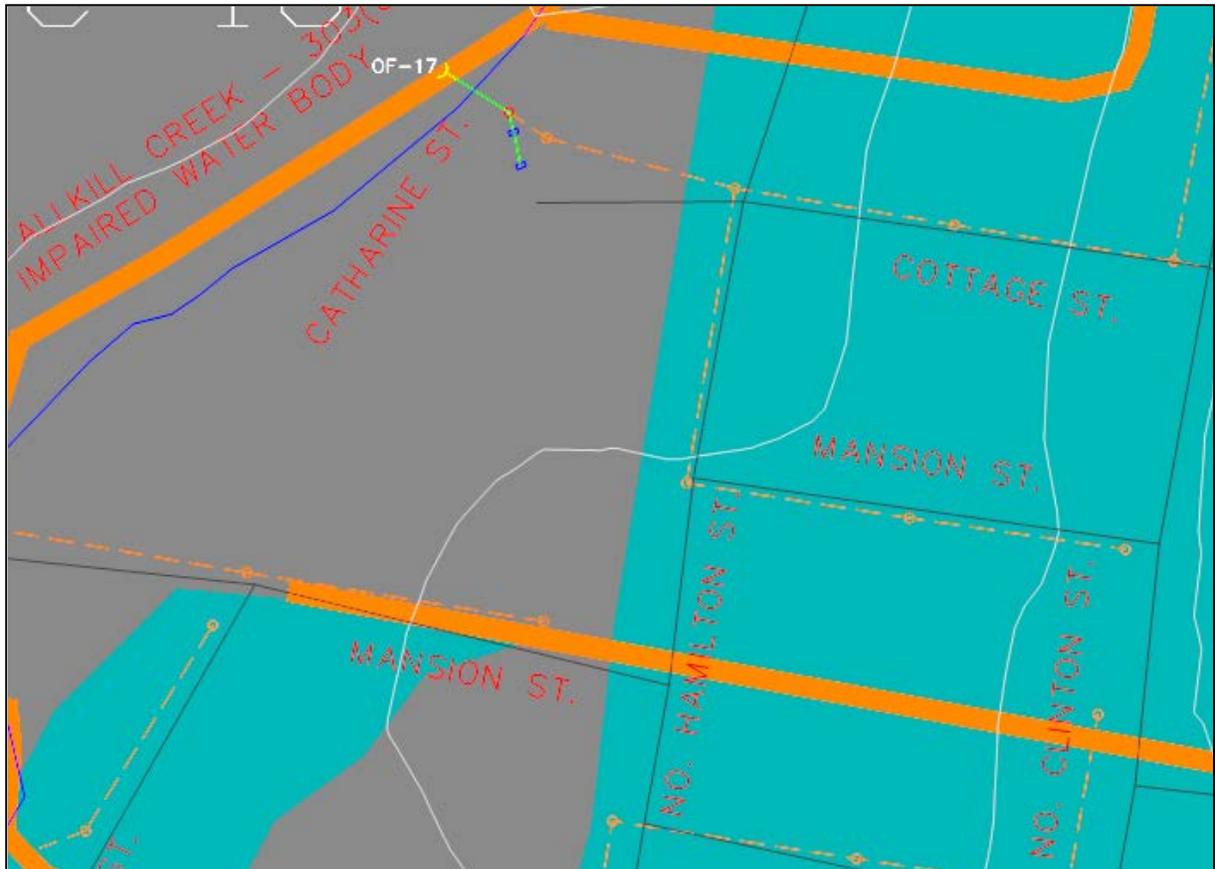
This older neighborhood lacks much in the way of municipal stormwater infrastructure, except for a storm drain at a low point at the bend of Catharine St., which drains directly to the Fall Kill (Green line and OF-17 below). The N. Hamilton St. portion of the neighborhood is the western edge of a large combined sewer area. As part of the city's plan to manage CSO's, separate storm sewer lines are proposed to direct stormwater from N. Hamilton, Mansion St., Cottage St. and N. Clinton St. into OF-17, as seen by the dashed orange line below.

**City of Poughkeepsie Stormwater Basemap: Blue area indicates combined sewer drainage area, with proposed storm drains in dotted orange. Solid green lines indicate existing storm drains, ending at outfalls numbered in white text. Note that Catharine St. is not complete on this map.**

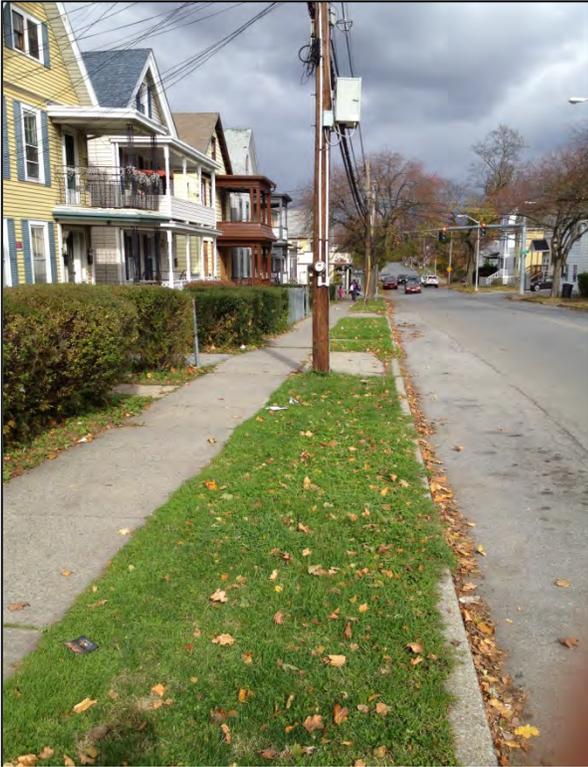
Streetview showing average home, street conditions, and potential for street trees.

The common areas between the street and sidewalk have a few street trees, but have enough space to accommodate additional trees or curb cuts to right-of-way bioswales. In addition, more frequent storm drain maintenance and street cleaning may be needed in this area, as there was notably more litter than in other nearby neighborhoods.

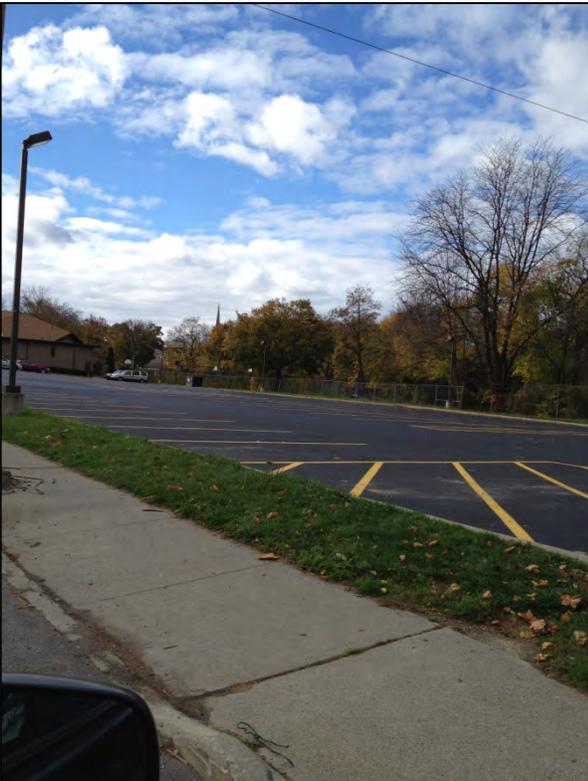
The lot at Beulah Baptist is a dominant feature in the landscape, and offers opportunity for enhancement.

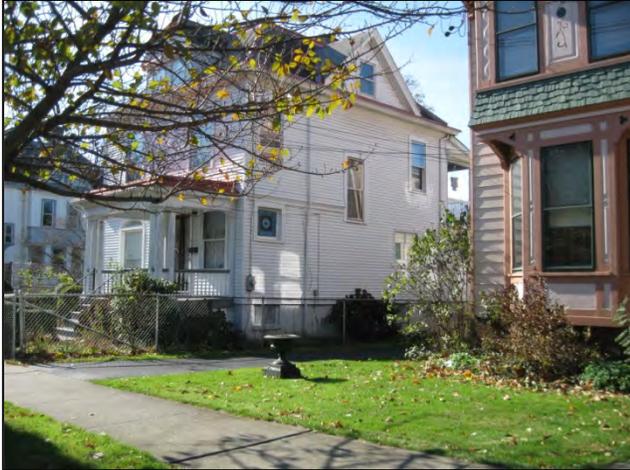
Typical lot with adequate pervious cover.

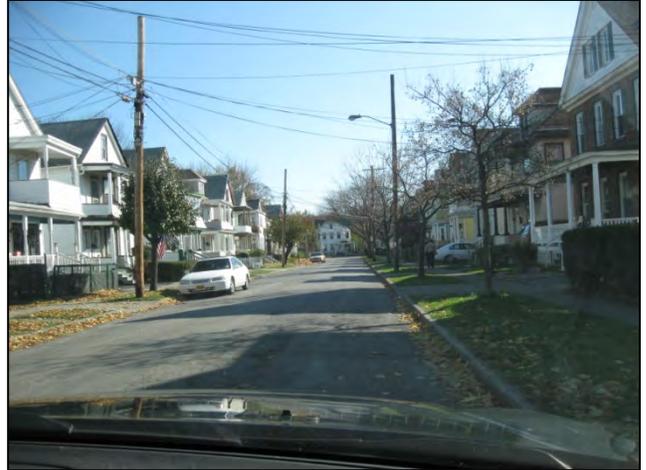
Example street showing common areas and presence of street trees.

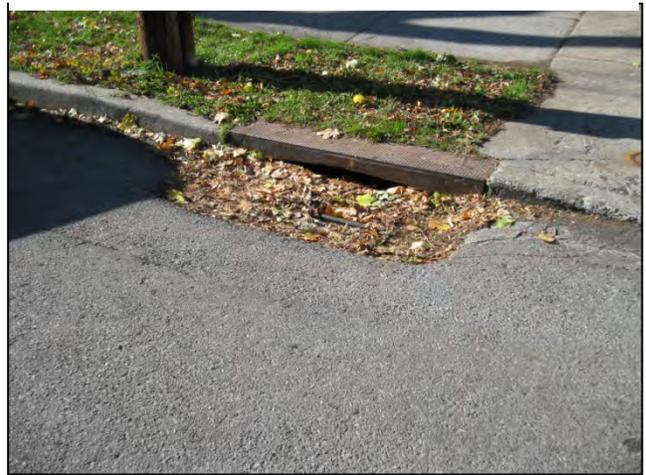
Most drains were clean, however some were partially clogged with litter and debris.

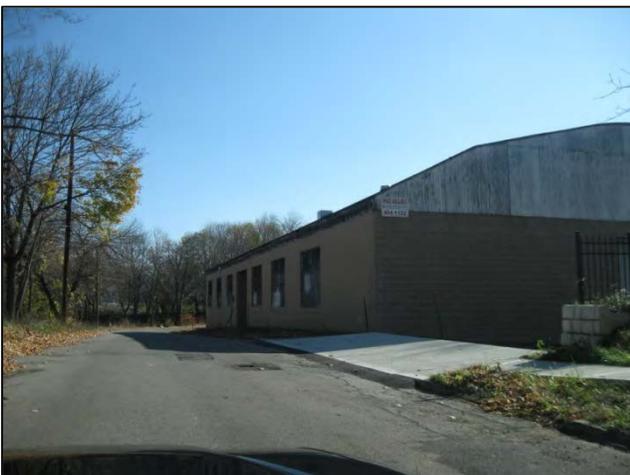
Industrial area on the eastern portion of the neighborhood.

Also, a small industrial/commercial corridor on the eastern edge of the neighborhood that includes the main County Office Building offers an opportunity for a trail or new access point; although at present the site is a hot spot for dumping.

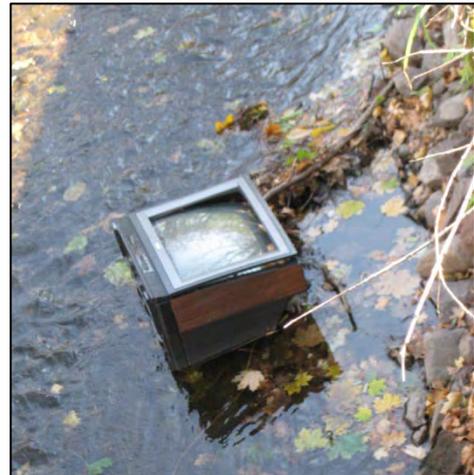
Recent dumping in industrial area.

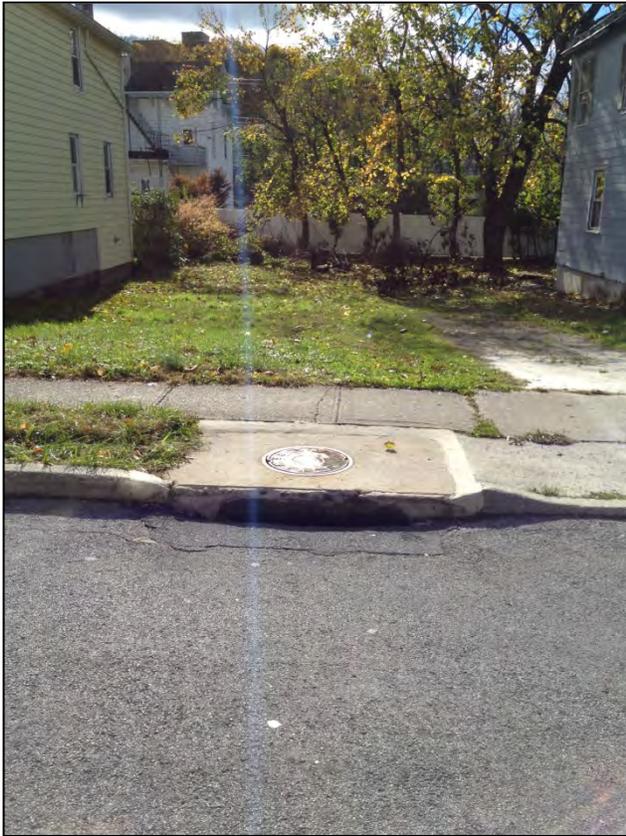
**Example of a vacant lot with restoration potential, with storm sewer in foreground.**

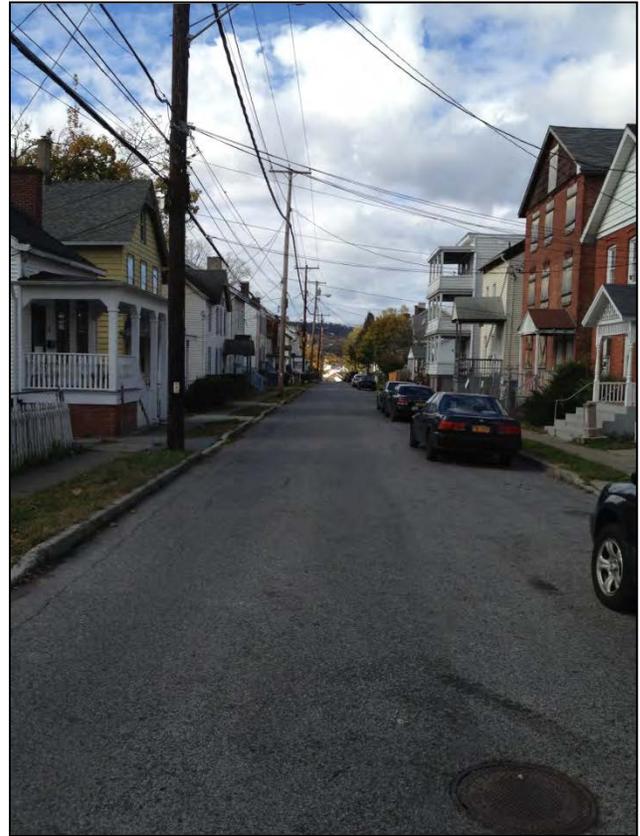
**View of Gifford Ave. showing potential for street trees and curb cuts.**

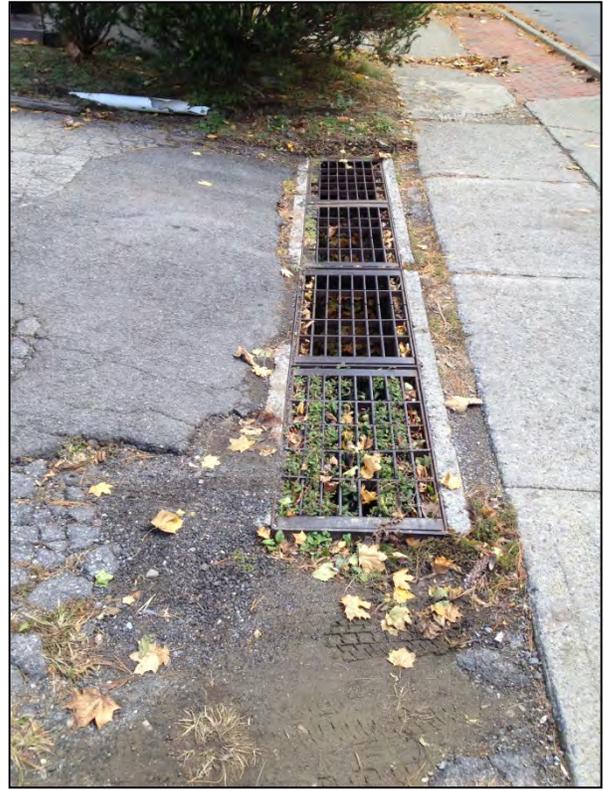
**Same drainage system, collecting water from large driveway.**

The apartment buildings offer opportunity for green infrastructure practices, as noted in the photo below in an example from the Baxter Building Corp property. In this case, stormwater from the rooftops and parking lot is routed to a series of drains that end up discharging directly to the Fall Kill, but there is opportunity to divert some of that stormwater into rain barrels and bioretention areas (see below).

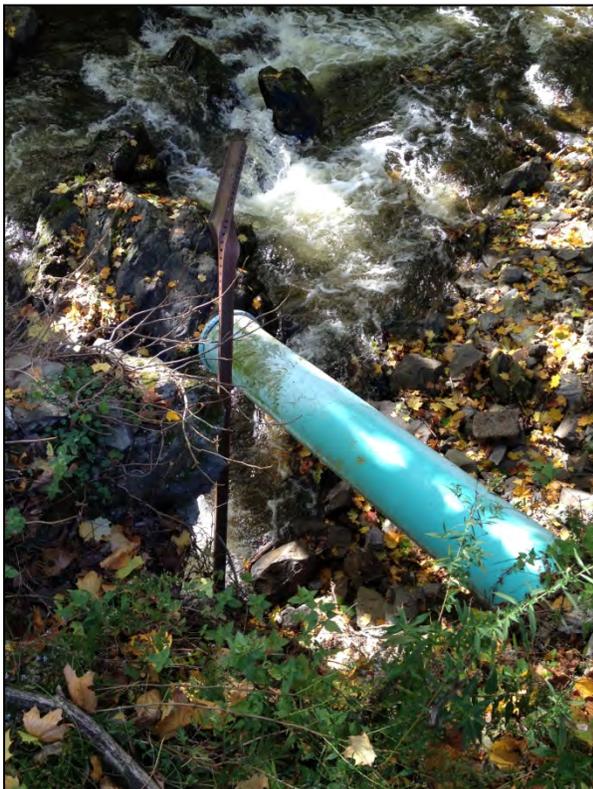
**The drains above end at this PVC pipe that dumps into the Fall Kill.**

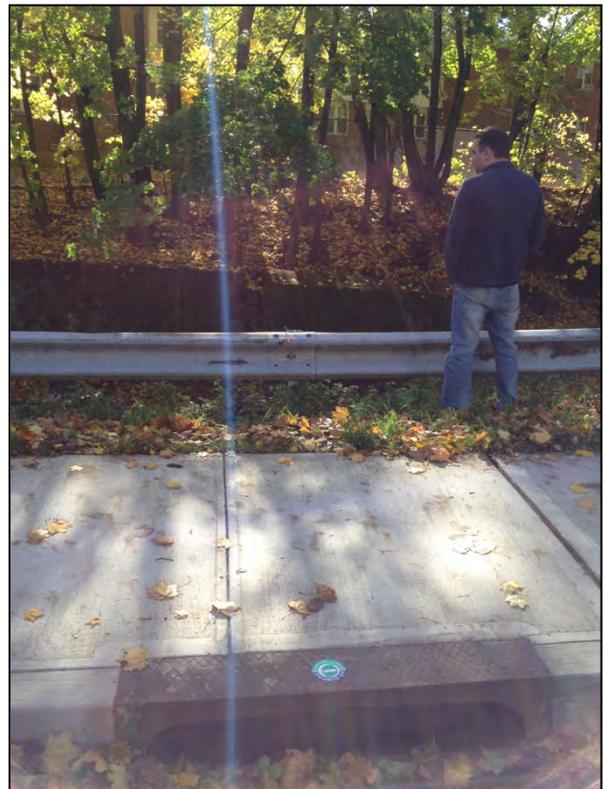
**Stenciled storm drain leading to the Fall Kill.**
